28 December 2021

Project 147041.10 – 301 Mission Street
Perimeter Pile Upgrade
Projection of Building Settlement Through Construction Completion

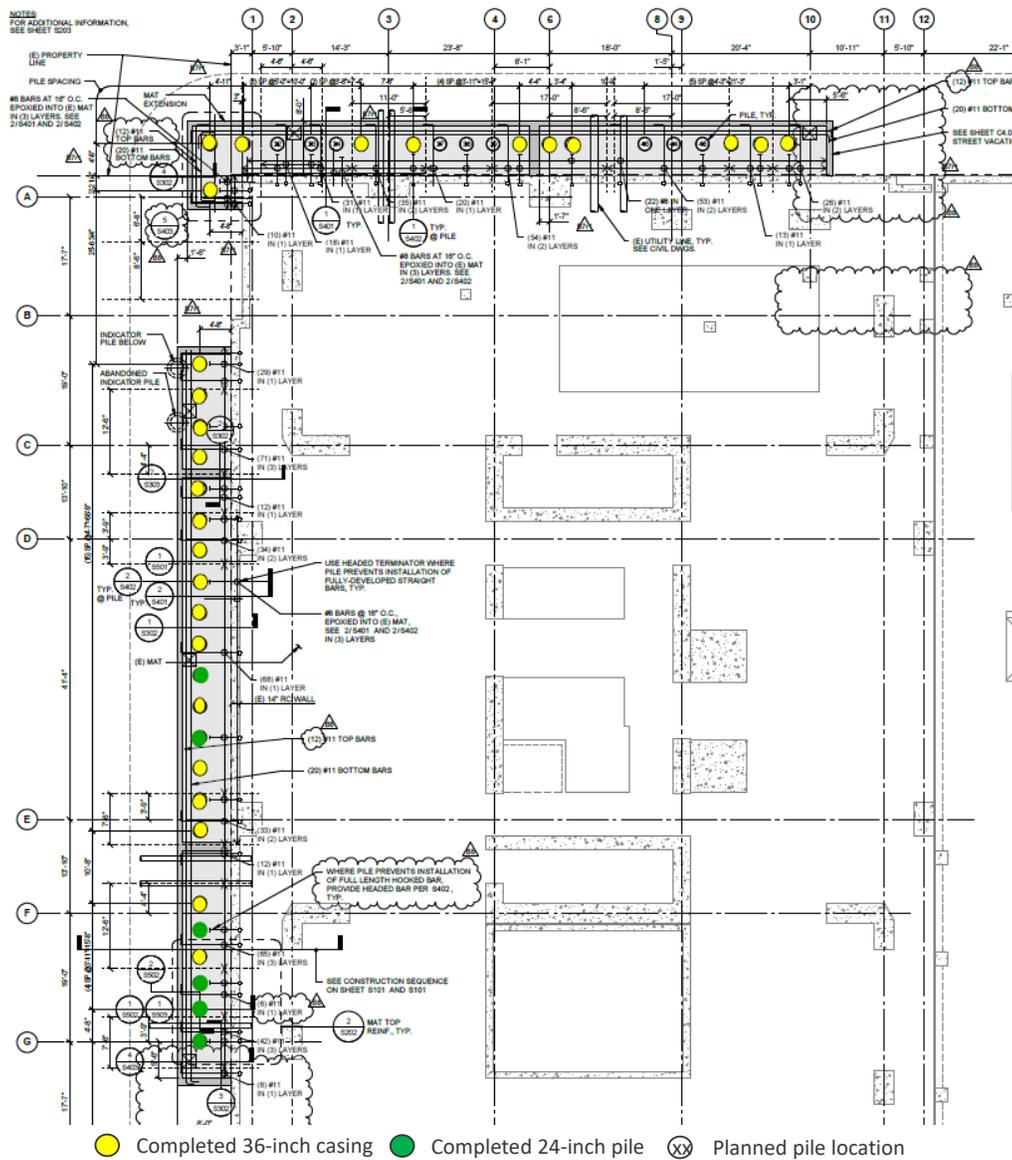
Figure 1 - Piles Installed as of 22 August 2021

24 in. piles along Fremont Street, simultaneously with the casings on Mission Street. We noted that this again resulted in an increase of the tilt rate towards the west, and on 30 July, I advised the project to halt installation of 36 in. casings, to allow us to understand the effect of installing the 24 in. piles alone. Then, after three more 24 in. piles were installed, on 22 August, I ordered a halt of all piling work, to allow analysis of this settlement increase and to determine if alternative means of pile installation could be developed, that would have less impact on the foundation's behavior. At that time, thirty-three 36 in. diameter casings and six 24 in. diameter piles had been installed. Figure 1 shows the locations of these casings and piles.

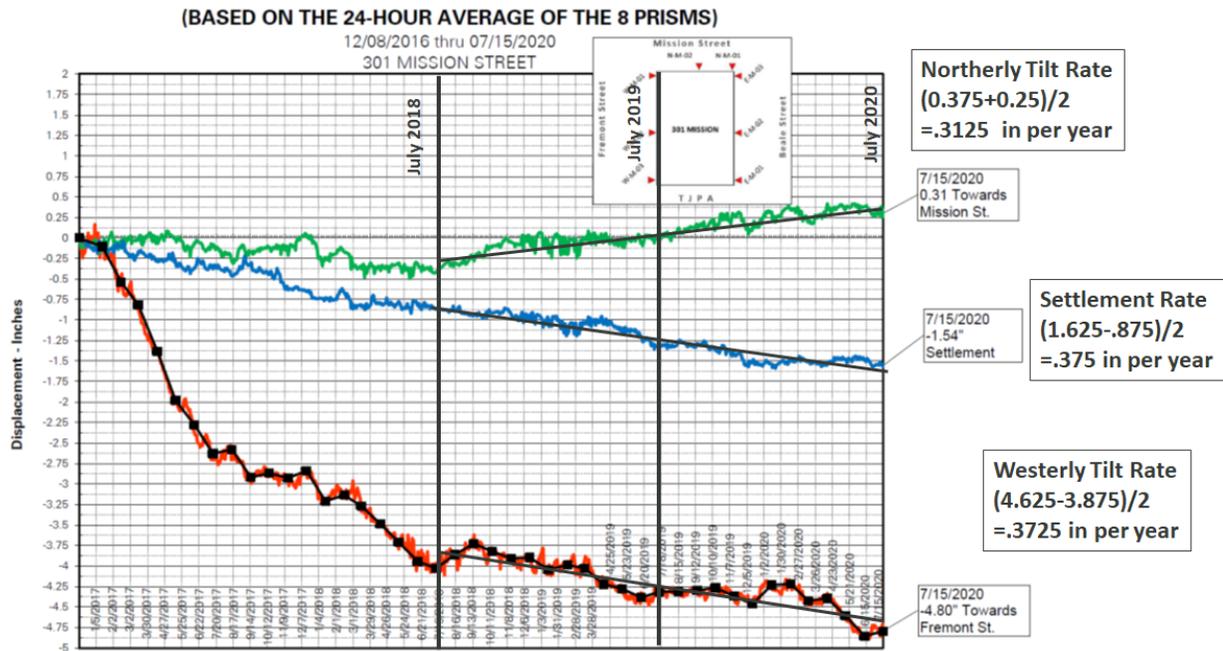
Figure 2 - Langan Survey Data – January 2017- July 2020

Figure 2 presents a summary of data obtained by Langan as produced in their final report in July 2020. This graph shows the average vertical settlement, tilt to the west and tilt to the north, as measured by Langan using the exterior-mounted prisms during the period extending from January 2017 through July 2020. Superimposed over the top of the plots are a series of straight lines indicating the long-term rate of increase of settlement and tilt during the period July 2018 – July 2020. In July 2020, Langan reported 16 in. of average vertical settlement, relative to the initial design elevations, 16.5 in. of tilting to the west, and 6.6 in. of tilting to the north, as measured using prisms at the top of the exterior facade. It should be noted that the scale of settlement shown in the figure has been adjusted to "zero" at the time Langan initiated their surveys. During the two-year period from July 2018 through July 2020, the data indicates

average vertical settlement at a rate of approximately 0.37 in. per year, tilting to the north at a rate of approximately 0.31 in. per year and tilting to the west at a rate of approximately 0.38 in. per year.

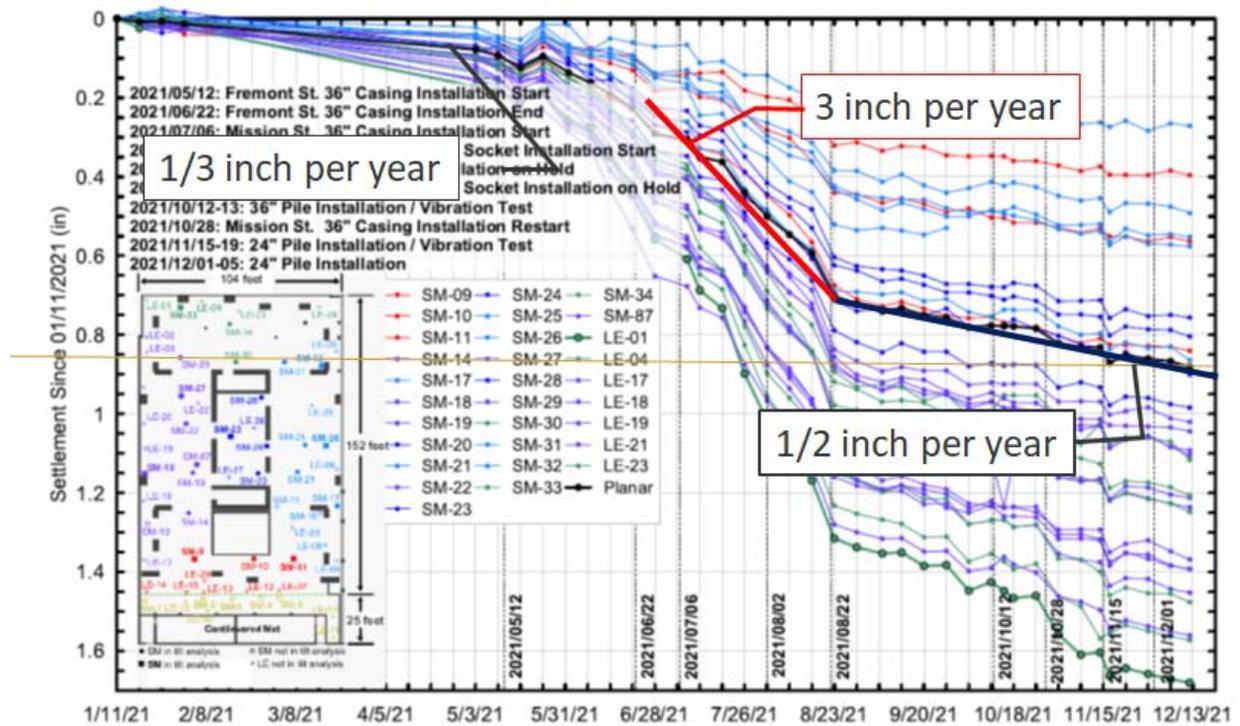
Figure 3 - Survey Data by Slate Geotechnical, January – December 2021

Figure 3, prepared by Slate Geotechnical Consultants, shows the survey data obtained from settlement markers on the base mat starting in January 2021 through the 7/15/2021 to the present. The figure shows the settlement over time measured at each of thirty individual settlement markers and the average of all thirty markers indicated as “average planar” in the figure. Four periods of activity are noteworthy in this figure: 1) the period from January 2021 through April 2021, during which construction activity was limited to clearance of utilities and site obstructions and the test pile program previously described; 2) the period from 1 May 2021 through 22 August 2021, during which the installation of thirty-three 36 in. diameter steel casings and six 24 in. piles occurred; 3) the period extending between 22 August 2021 and 12 October 2021, during which there was a moratorium on construction activity; and lastly, the period between 12 October 2021 and 15 December 2021, during which the pilot pile installation program occurred. We refer to these four periods as: 1) pre-construction; 2) production piling; 3) moratorium; and 4) pilot program, respectively. During the pre-construction period, the average planar settlement increased at a rate of approximately 1/3 in. per year, which is similar to the 0.38 in. per year shown by Langan during the prior two years. During the production piling period, settlement increased to a rate of 3 in. per year, increasing as more casings and piles were installed. Following the institution of the moratorium, the settlement quickly returned to an average rate of about 1/2 in. per year, slightly more than before the piling, but

still similar to that recorded by Langan in the period 2018-2020. The rate of 1/2 in. per year has been maintained throughout the pilot program period.

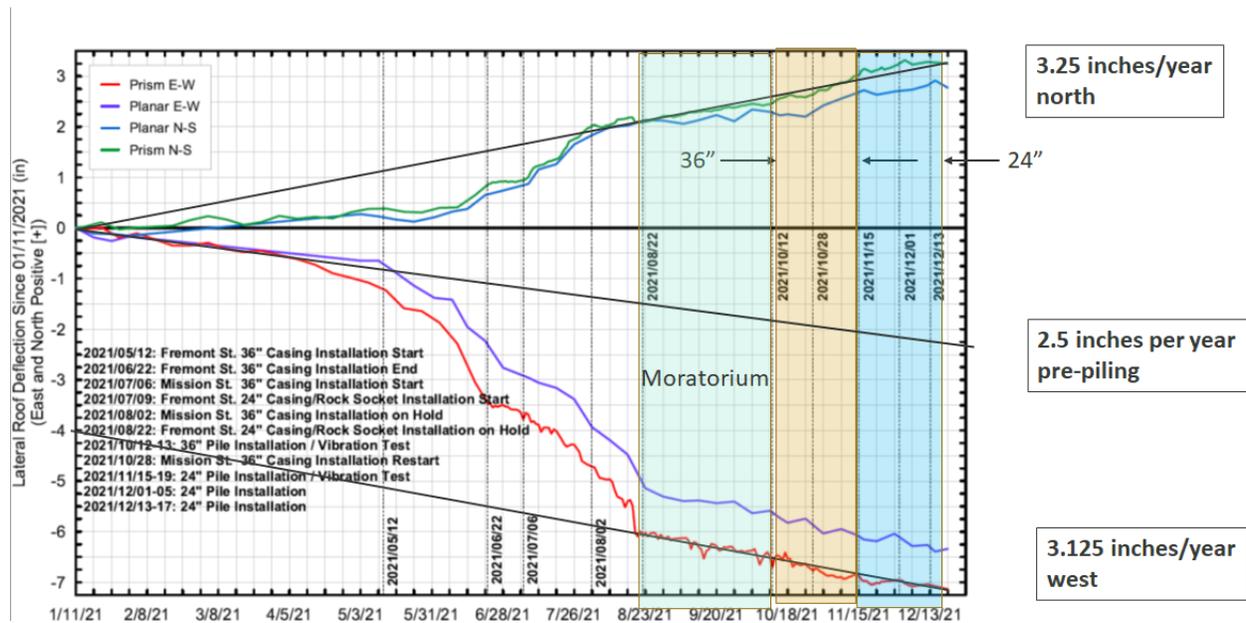
Figure 4 Building Tilt Survey Data January – December 2021

Figure 4 presents a plot of building tilt from January 2021 through the present as measured by the lateral deflection of the roof using the same prisms installed by Langan. Four plots are included in the figure: 1) east-west prism data (red); 2) east-west roof deflection inferred by calculation from an assumed rigid body rotation of the building (light blue); 3) north-south prism data (green) and 4) north-south deflection inferred by calculation assuming rigid body rotation (dark blue). The figure shows tilting to the west at a rate of 2-1/2 in. per year in the pre-construction period and 3-1/8 in. per year during the moratorium and pilot program periods. Similarly, tilt to the north is shown as: approximately 1 in. per year during the pre-construction period and 3-1/4 in. per year during the moratorium and pilot program periods. The pilot program has not significantly affected the tilting rate either to the north or west relative to that which occurred during the moratorium, and in fact, the plot shows some decrease in the rate of tilt to the north and west during the 24 in. pilot pile installations.

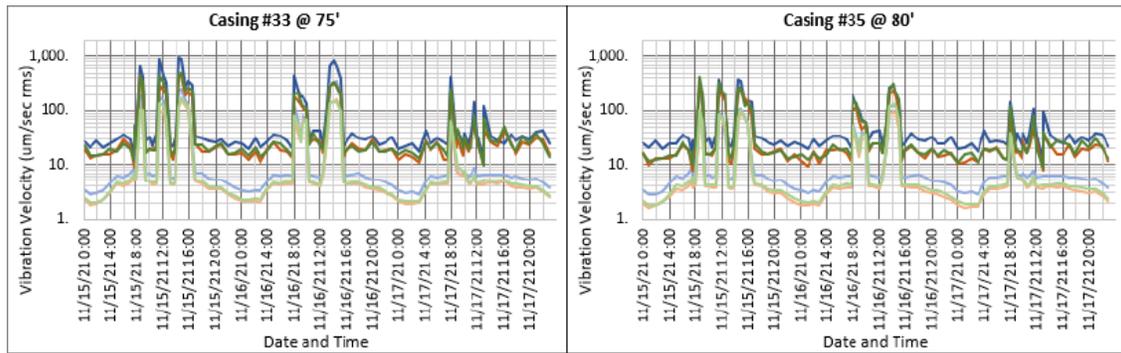
Figure 6 - Mean and Maximum Vibration Levels within the Colma Formation During Installation of Pilot Casing 33

Figure 5 shows the locations of vibration sensors during the pilot installations of 36 in. casings, at locations 32, 33 and 34, and also during the installation of 24 in. pilot piles at locations 30 and 31. Figure 6 shows the mean and maximum root mean square velocities recorded within the Colma formation during the installation of the 36 in. casing at location 33. The maximum vibration amplitudes recorded at depth were on the order of 600 micro-m/s and occurred during excavation of soil from within the casing using the auger bucket, as the casing tip was extended from the 70 ft to 90 ft depth, that is within the lower Colma formation.

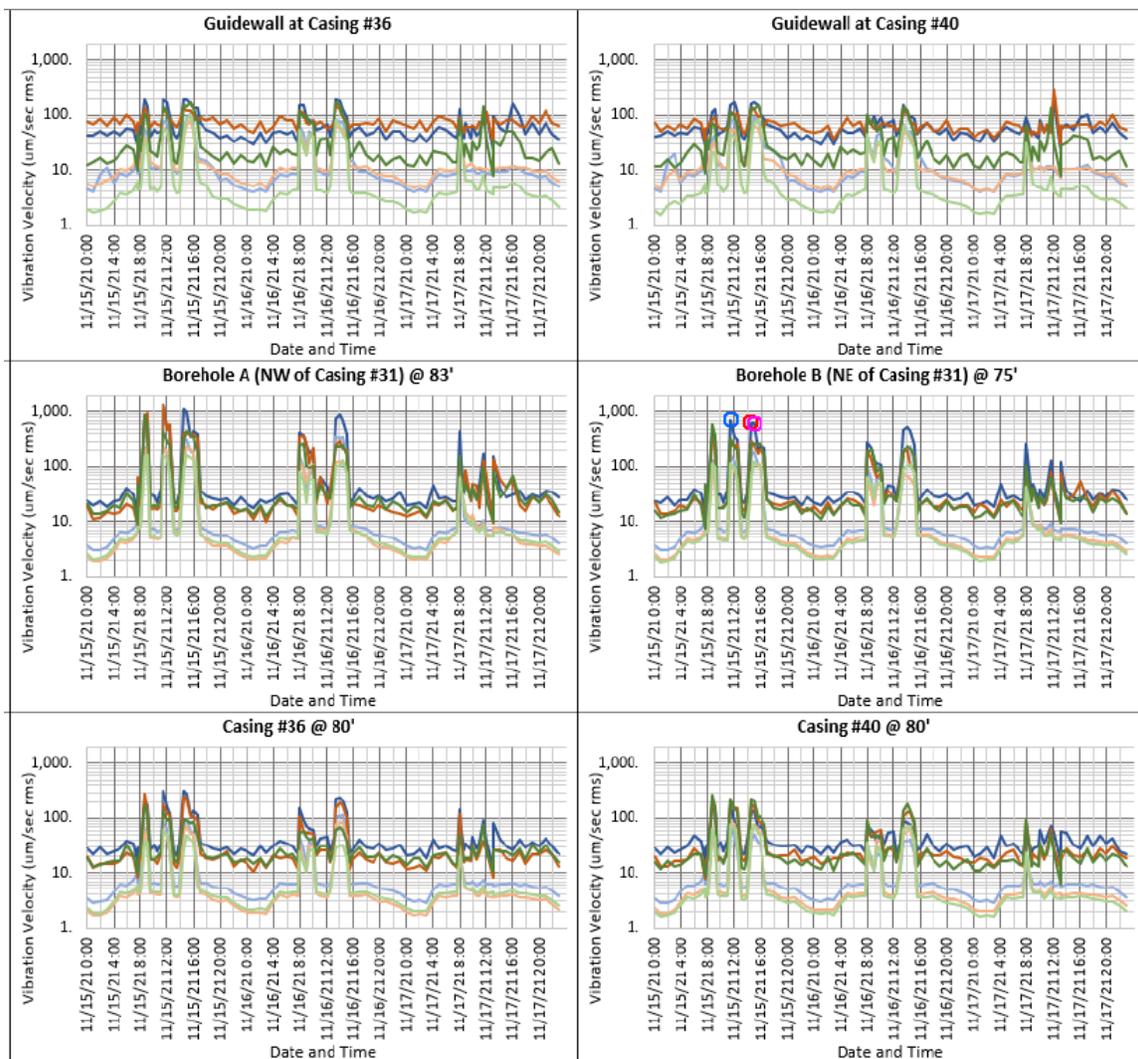
Figure 7 - Mean and Maximum Vibration Levels within the Colma Formation and at the Guide Wall During Installation of Pilot Pile 30

Figure 7 shows the mean and maximum root mean square velocities recorded at depth and at the guide wall during the installation of the 24 in. pile at location 30. The maximum vibration amplitude within the Colma sand was somewhat higher than for the installation of the 36 in. casing, with peak root mean square velocity of about 1,000 micro-m/s. This amplitude occurred as the 24 in. pile was advanced through the soil plug within the 36 in. casing at 100 ft below grade and decreased as the drill tip progressed deeper into the underlying soil. Also, the amplitude of velocity at the guide wall was approximately 1/5 that recorded at depth within the soils. Not shown in the figure but evident from spectral analysis of the vibration waveform is that the frequency of maximum energy content within the Colma sands matches the firing rate for the drill bit. We interpret this as evidence that vibration within the Colma formation during 24 in. pile installation is primarily caused by firing of the drill bit, that transmission of vibration from the guide wall through the casings is not a significant factor, and that isolation of the guide walls from the casings and the crane from the guide wall is not necessary. This is particularly evident given that the installation of pilot pile No. 26, occurred without separation of the casings from the guide wall and did not have a significant effect on building settlement or tilt.
