# Pedestrian Bridge Collapse Over SW 8th Street Miami, Florida March 15, 2018

## Accident Report

NTSB/HAR-19/02  
PB2019-101363

National  
Transportation  
Safety Board

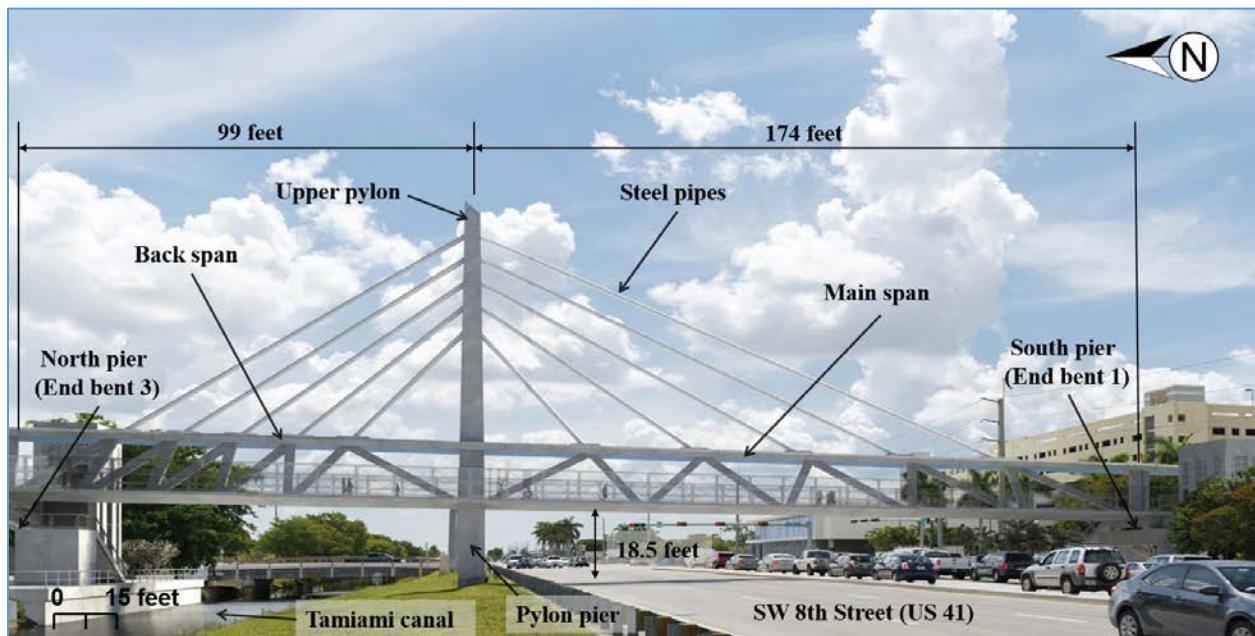
**Figure 2.** East-view rendering of completed UCPP pedestrian bridge. Note: This depiction does not illustrate the 11-foot northward shift of the bridge to accommodate a future westbound express bus lane on SW 8th Street or the construction of a bulkhead wall on the south Tamiami Canal bank. (Source: FIU, annotated by NTSB)

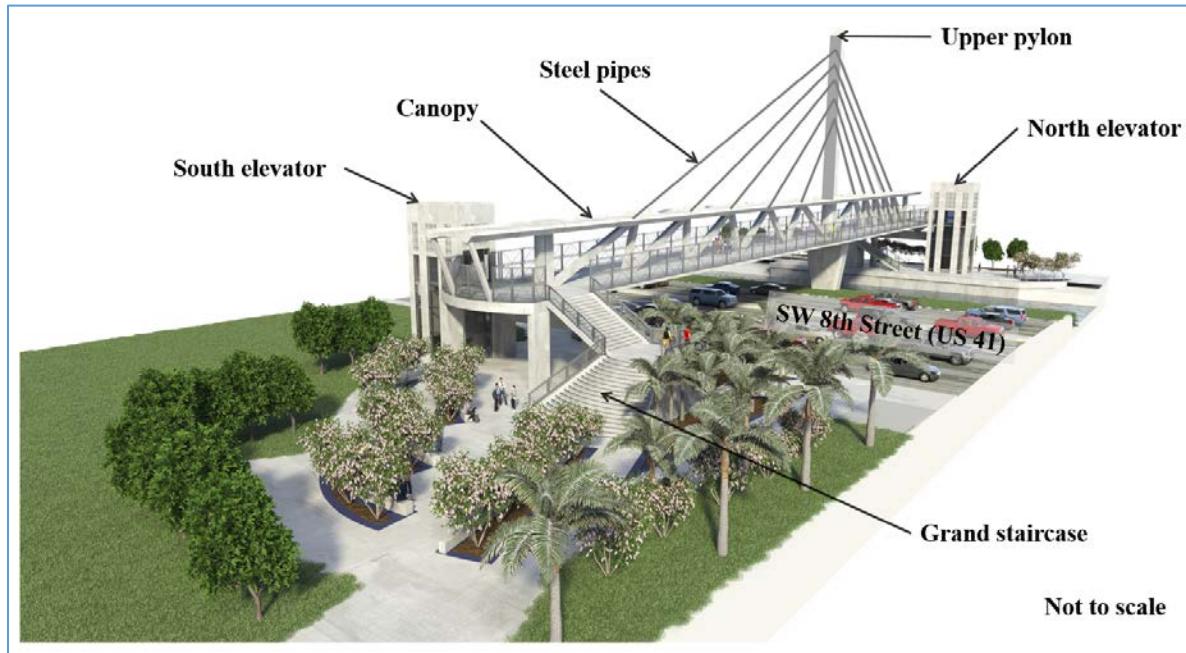
**Figure 3.** Design rendering of completed pedestrian bridge. (Source: FIU, annotated by NTSB)

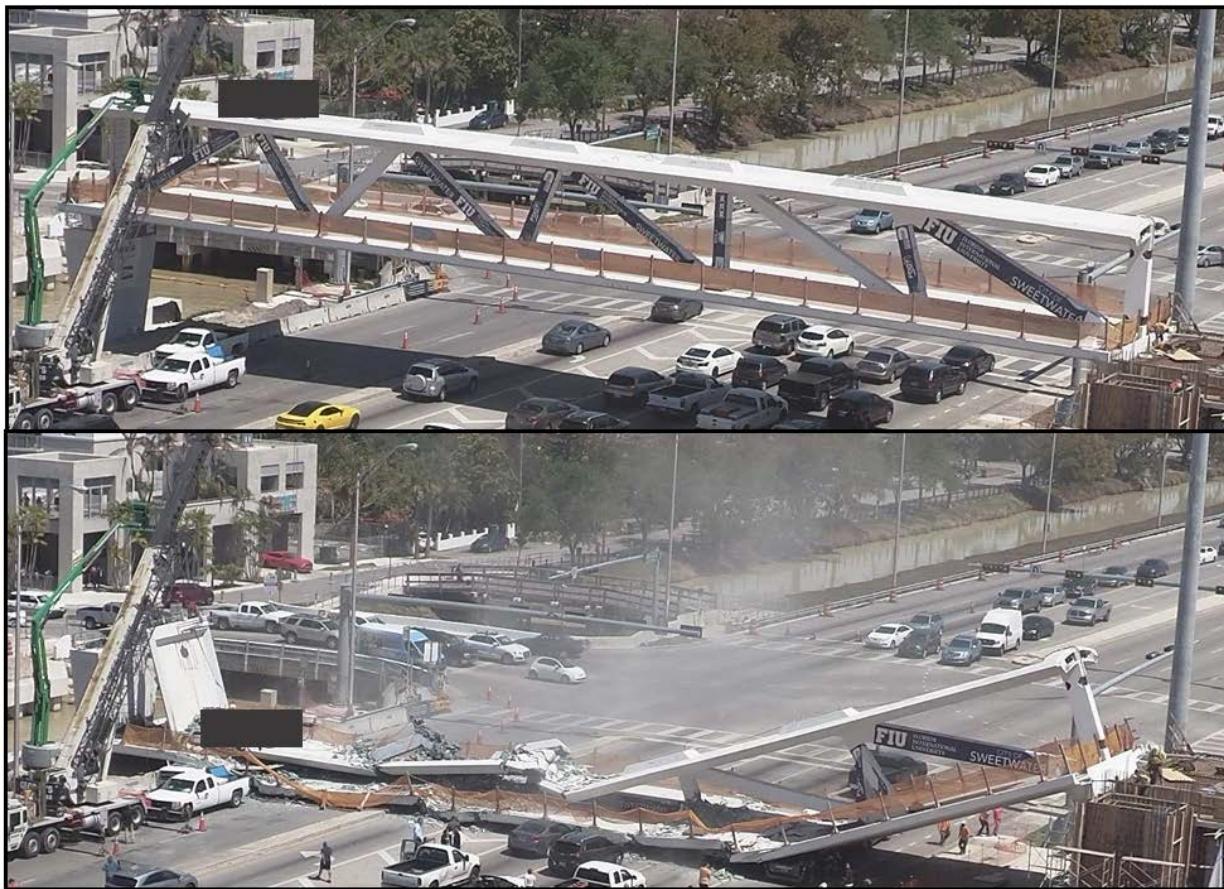
**Figure 4.** Still images from FIU parking garage camera, showing east views of pedestrian bridge, March 15, 2018, precollapse (top) and postcollapse (bottom). (Source: FIU video camera)

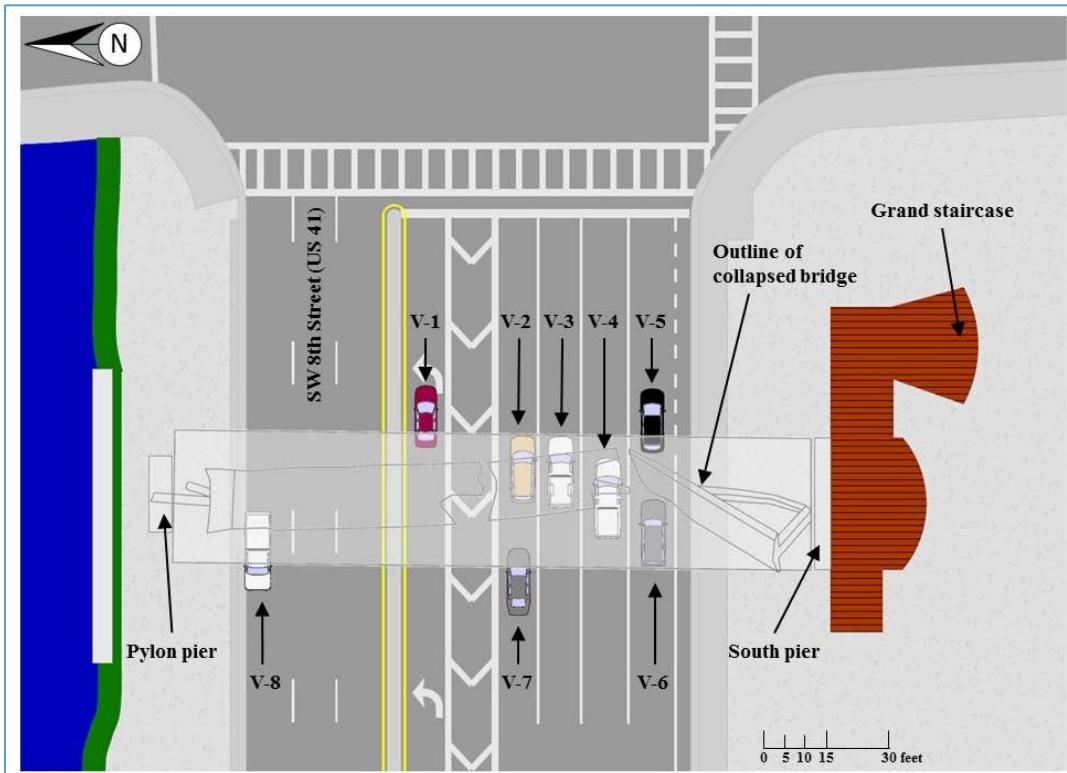
**Figure 5.** Scene diagram of vehicles under or proximate to bridge at time of collapse, with vehicle reference numbers.

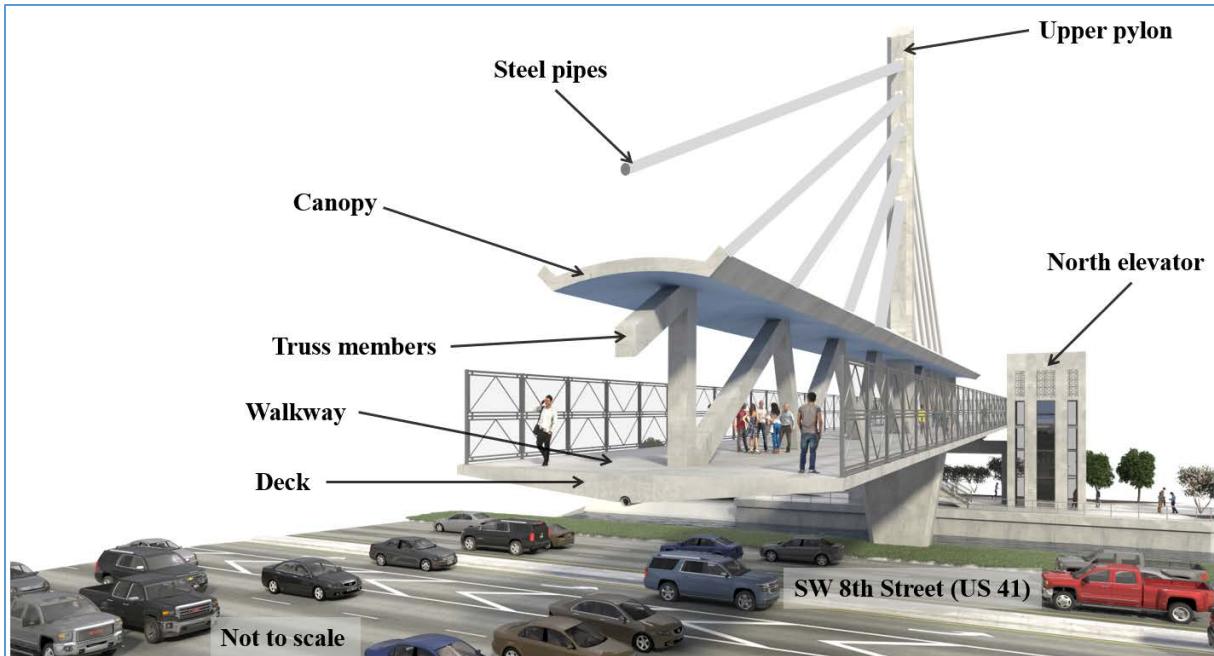
**Figure 6.** Cross-section rendering of pedestrian bridge, north view. (Source: FIU, modified by NTSB)

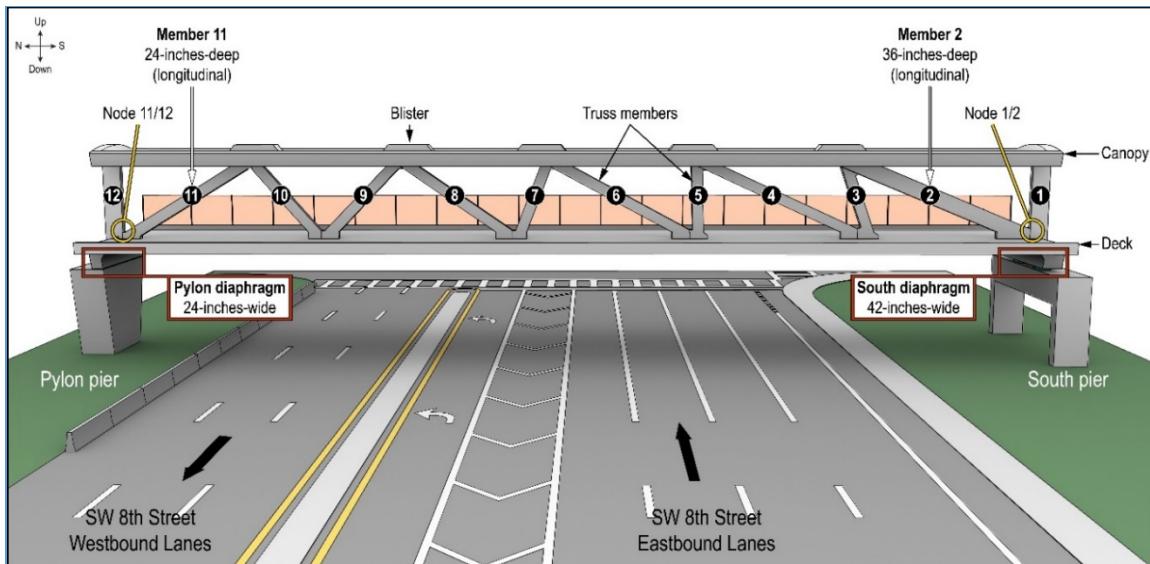
The main span included 12 truss members, whose placement and numbering are shown in figure 7. Truss members were aligned along the structure's centerline. Each of the members measured 1 foot 9 inches wide (transverse direction) and ranged from 2 to 3 feet deep (longitudinal direction). In addition to the upper pylon and 10 steel pipes, the design incorporated north- and south-end staircases and elevators. The steel pipes were functional structural members designed to increase the bridge's natural frequency—that is, to dampen the vibrations from pedestrian traffic. They were not load-carrying structural elements.

**Figure 7.** Nomenclature of bridge components and numbering of diagonal and vertical truss members on main span of pedestrian bridge, east view.

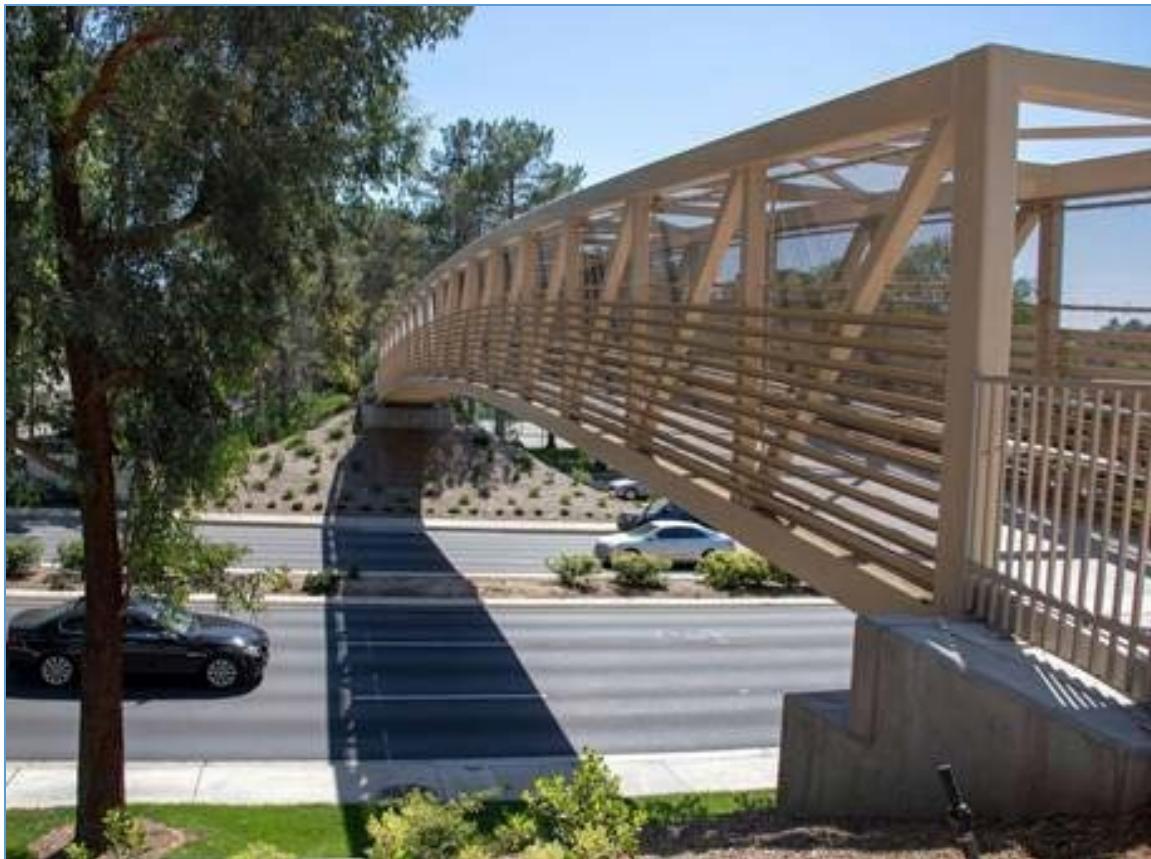
**Figure 8.** Typical truss bridge with one set of regularly spaced vertical truss pieces running along each side, with top lateral bracing constructed of steel. (Source: [Santa Clarita, California](#))

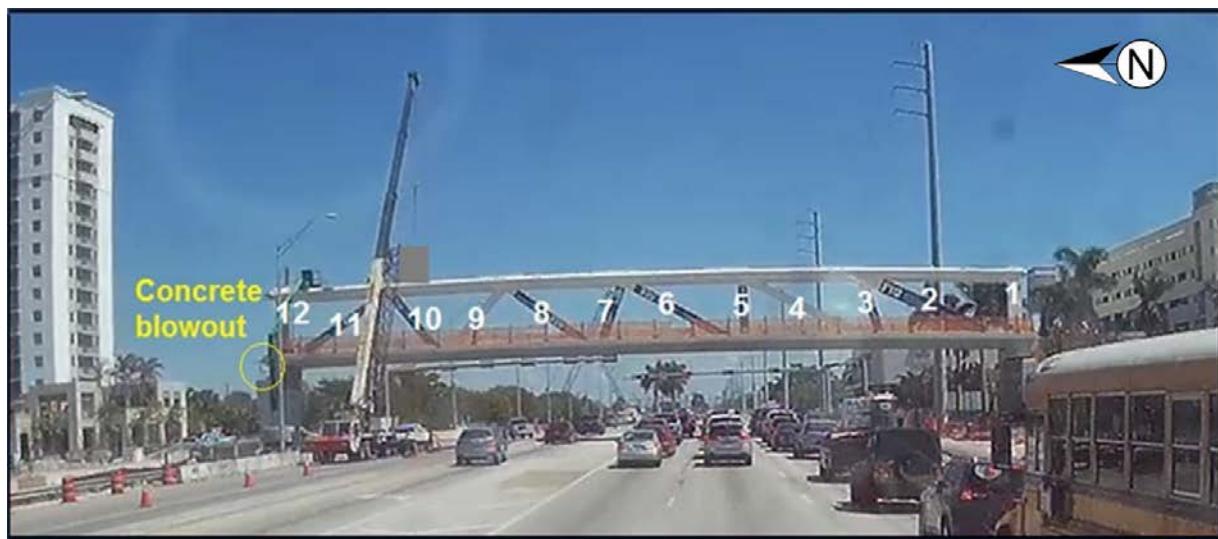
**Figure 9.** Still image (time stamp 13:46:43:881) from in-vehicle mounted video camera on pickup truck traveling east on SW 8th Street, showing concrete dust and debris blowout at north end (pylon pier), March 15, about 1:46 p.m.

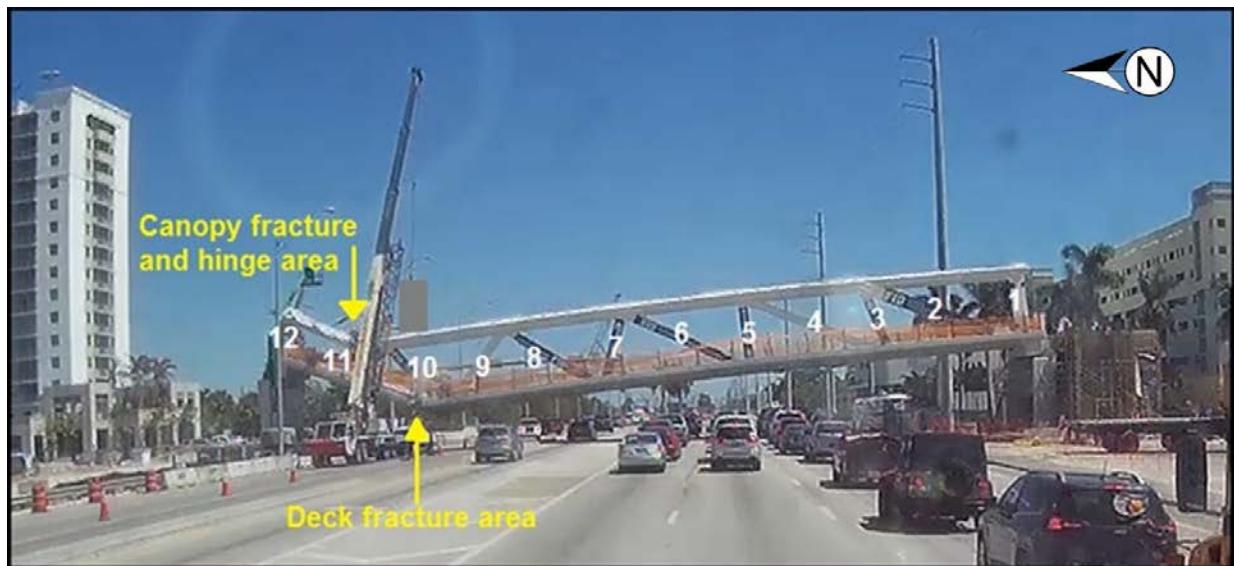
**Figure 10.** Still image (time stamp 13:46:44:046) from in-vehicle mounted video camera on pickup truck traveling east on SW 8th Street, showing full-width canopy fracture and deck fracture areas at north end (pylon pier), March 15, about 1:46 p.m.

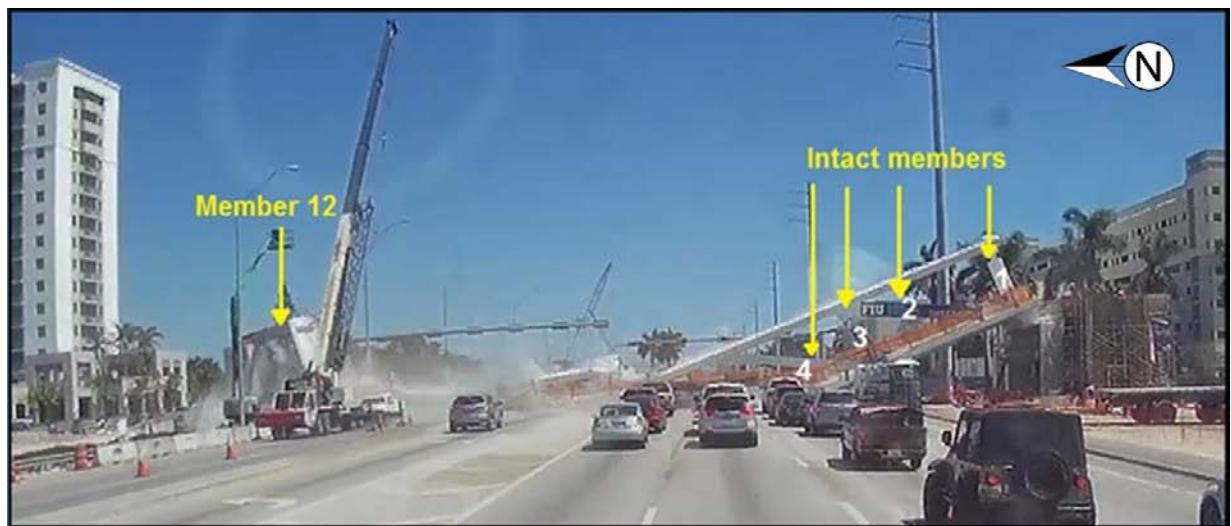
**Figure 11.** Still image (time stamp 13:46:44:310) from in-vehicle mounted video camera on pickup truck traveling east on SW 8th Street, showing main span completely collapsed, March 15, about 1:46 p.m.

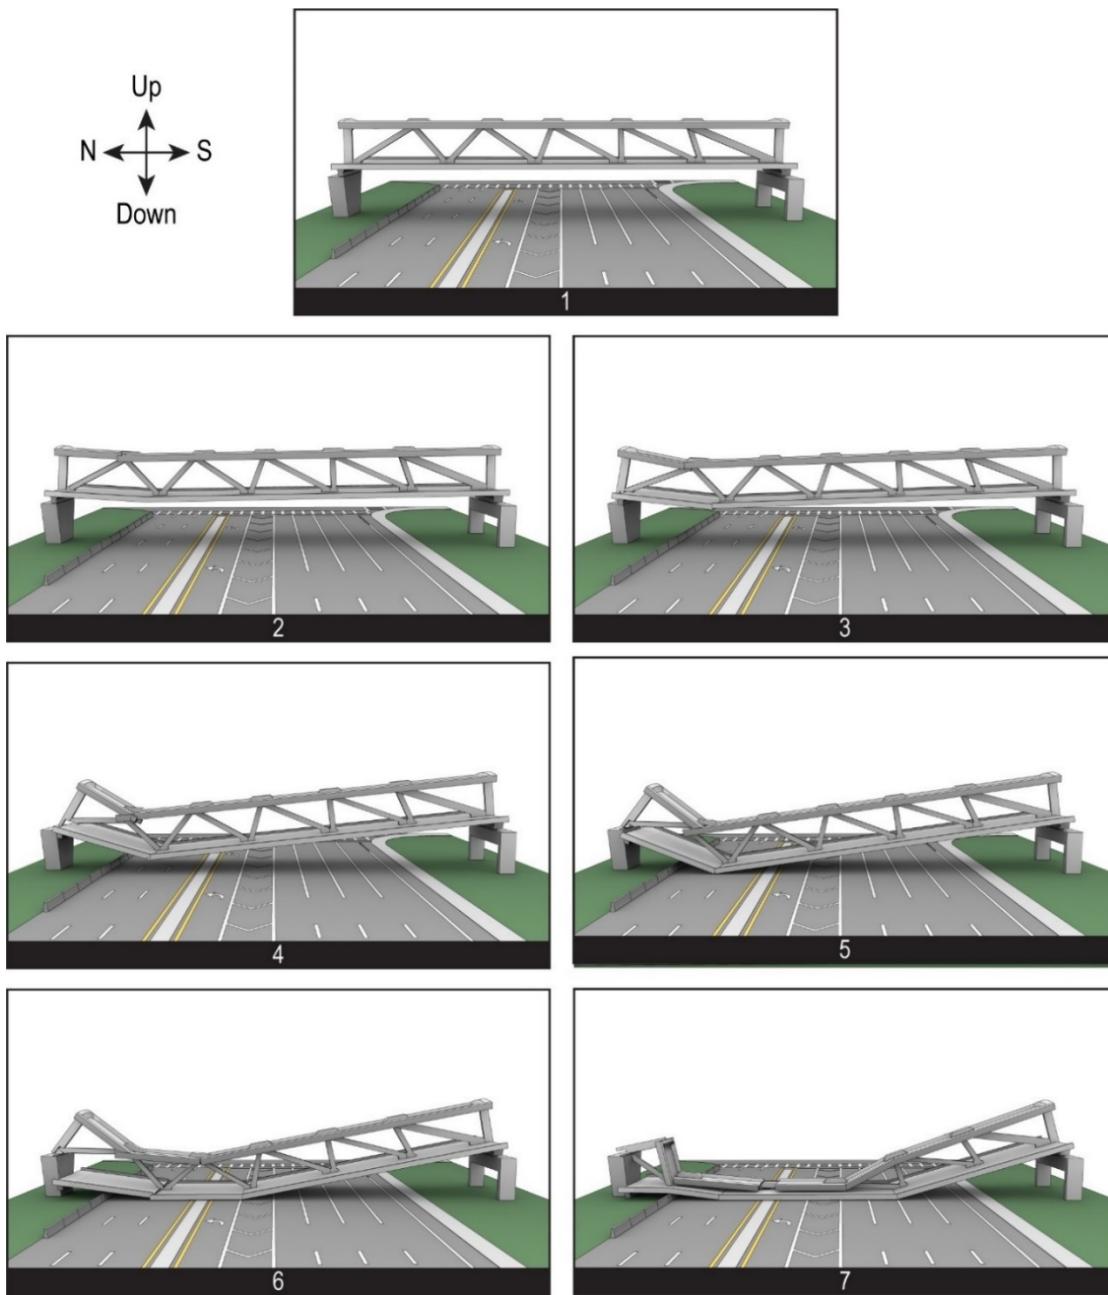
During the collapse sequence, which initiates at the north end, the entire span falls and breaks into multiple sections in the north-to-south direction, as depicted in figure 12. The south and pylon piers appear to have remained vertical and stationary postcollapse, with minimal damage.

**Figure 12.** Collapse sequence diagram, facing east, depicting bridge's precollapse condition in phase 1 through postcollapse position (onto SW 8th Street) in phase 7.

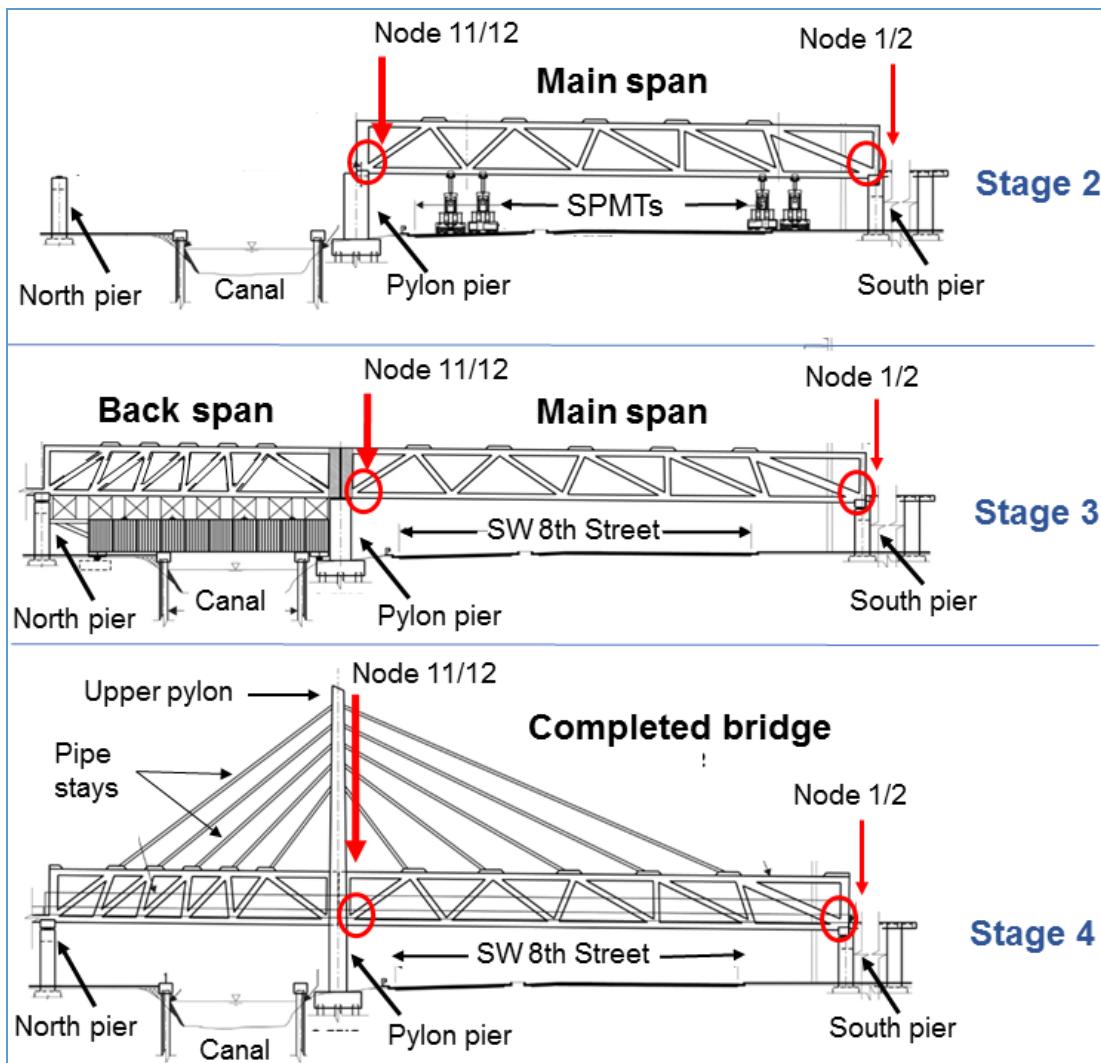
**Figure 13.** Construction stages 2–4, east view. (Source: FIGG, annotated by NTSB)

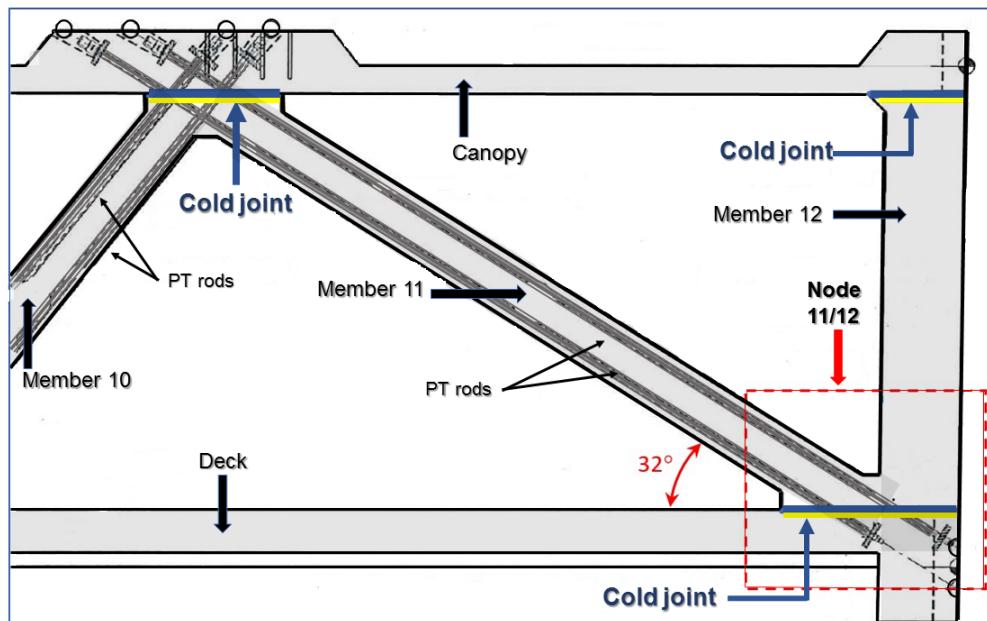
Sections of formwork are filled to the top with concrete, which must harden prior to the installation of additional formwork and the placement (pour) of subsequent semiliquid batches of concrete. Subsequent concrete castings rest on the earlier, hardened castings. The surface between the two castings is referred to as a "cold joint."<sup>28</sup> (See figure 14.)

**Figure 14.** Cold joints on pedestrian bridge main span north end, at intersection of members 10, 11, and 12 at canopy and at node 11/12 connection to deck at pylon pier. [Note: View is looking west]

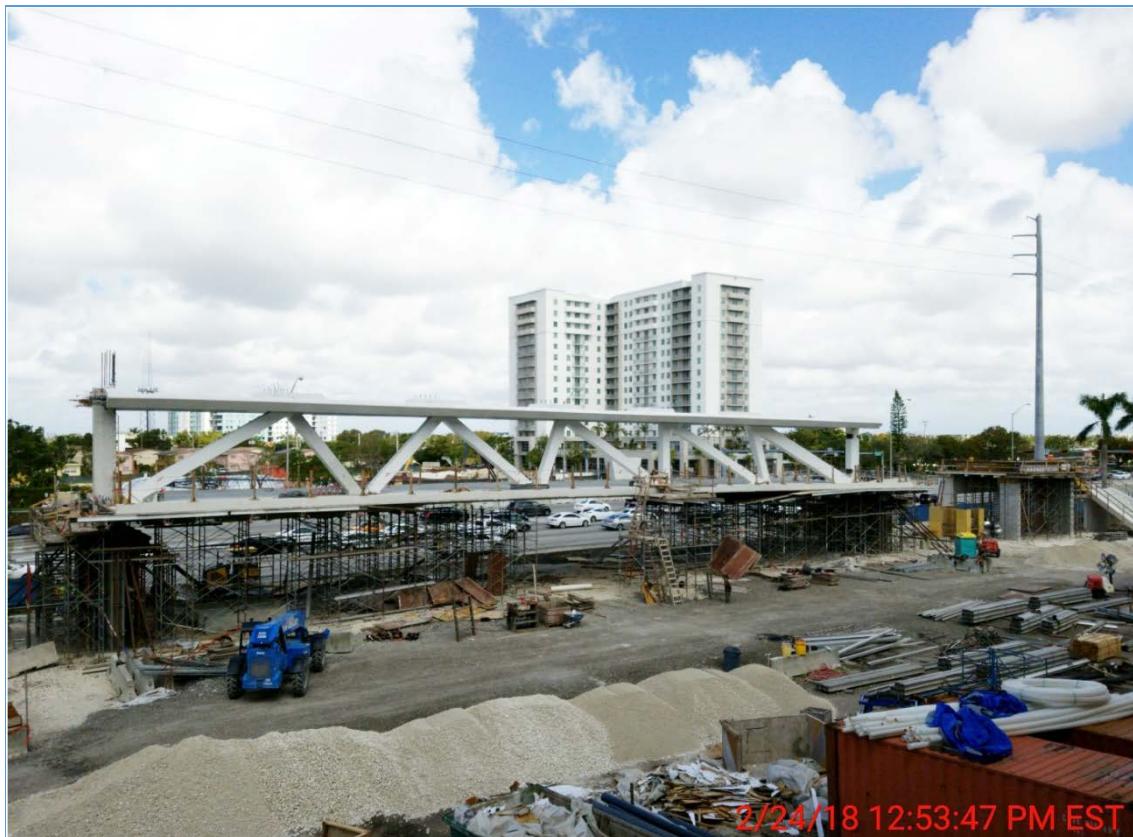
**Figure 15.** Temporary falsework supporting the bridge span in the casting yard on February 24, 2018, being sequentially removed from the middle of the span toward the ends of the span. (Source: MCM)

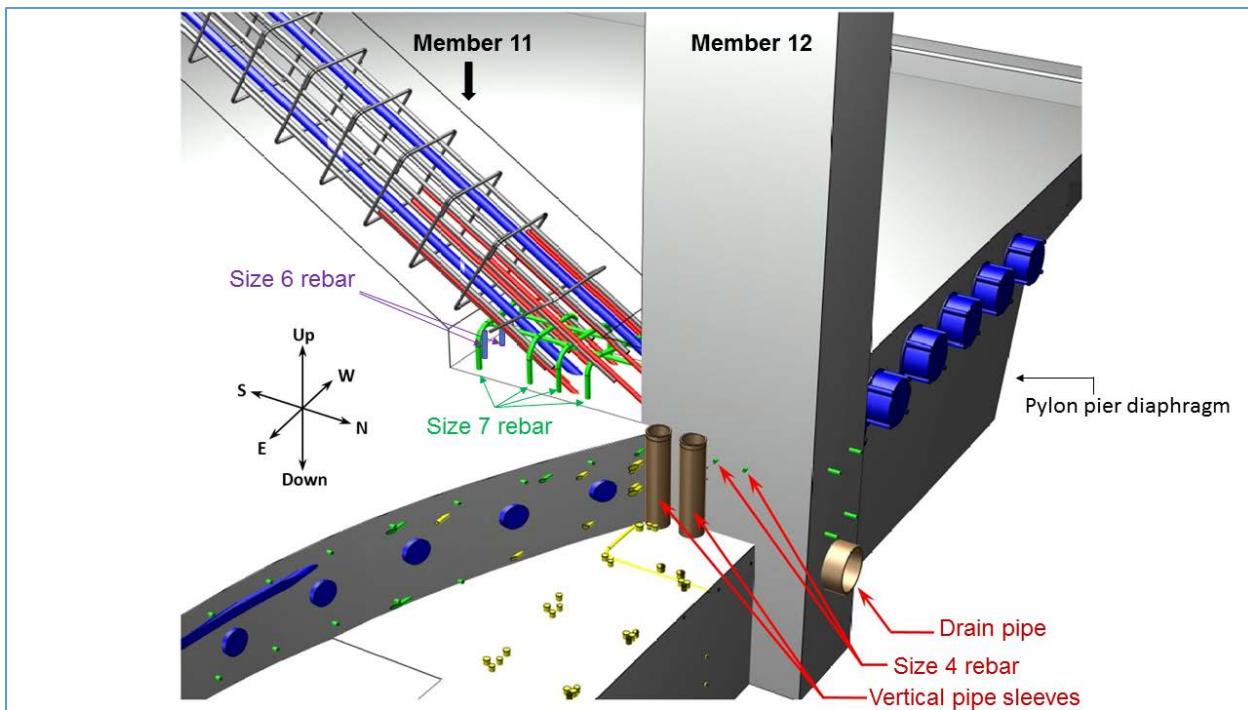
**Figure 16.** Main span, north end, showing steel rebars in member 11, vertical pipe sleeves, end of drain pipe location, and size 4 rebar at member 12. (Source: FHWA 2019)

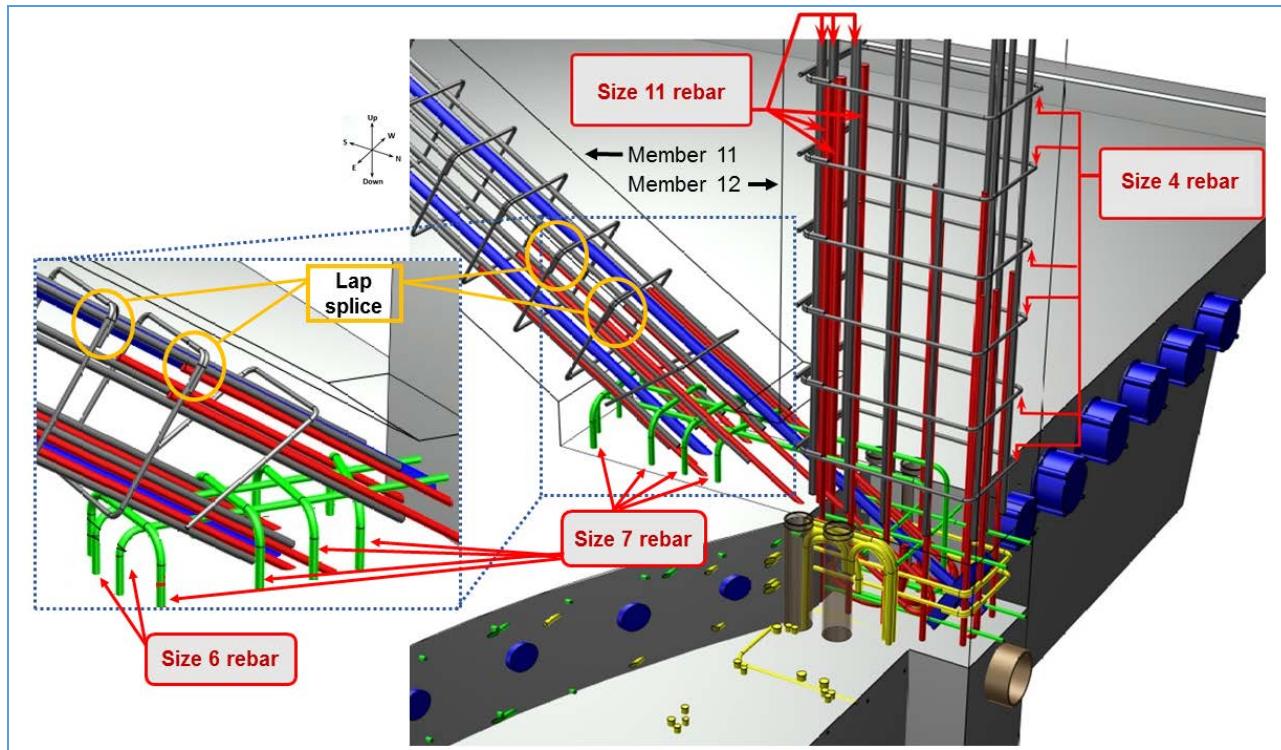
**Figure 17.** Main span, north end, showing rebar detailing in member 11, member 12, and node 11/12. Inset shows another view of rebar in node 11/12 and detail of lap splice from member 11. (Source: FHWA 2019)

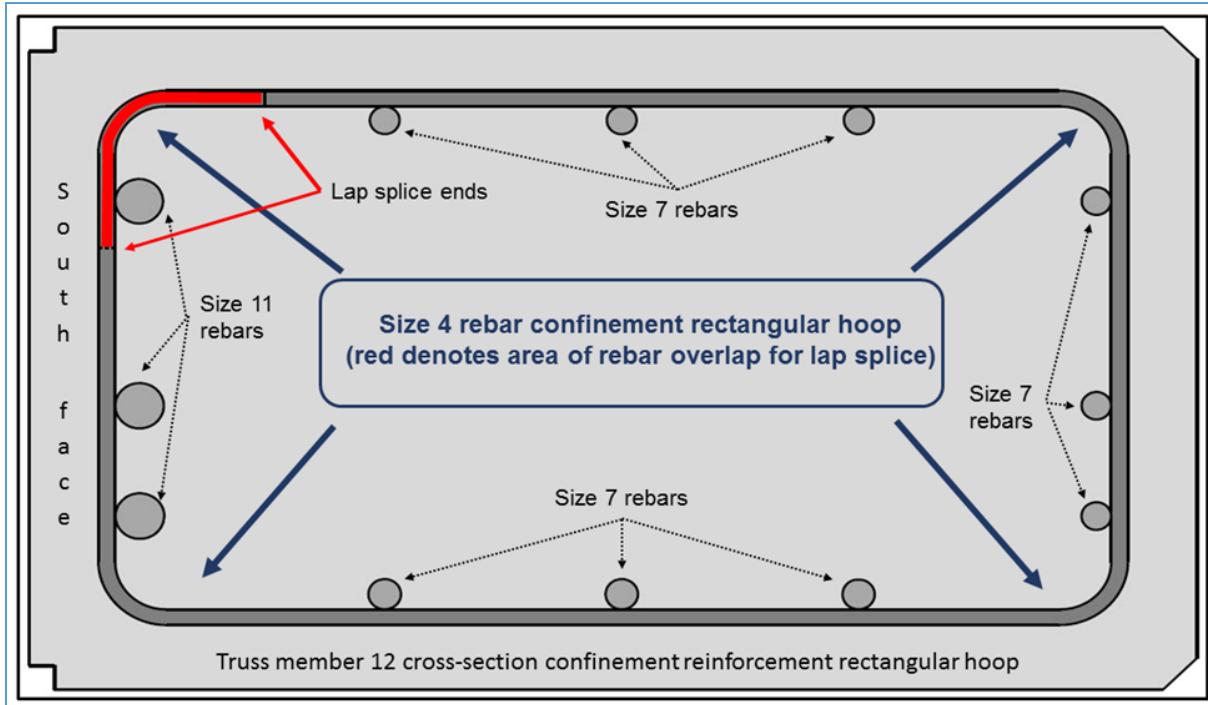
Figure 18 is a cross section of the reinforcement within member 12, showing the size 11 rebars (1.4 inch diameter) for longitudinal reinforcement as larger circles on the left (south face). The remaining circles represent the size 7 rebars (0.875-inch diameter) for longitudinal reinforcement around the perimeter. The confinement rectangular hoop in member 12 was composed of size 4 rebars (0.5 inch diameter).

**Figure 18.** Cross section of truss vertical member 12 concrete-embedded rebar confinement hoop and rebars with lap splice.

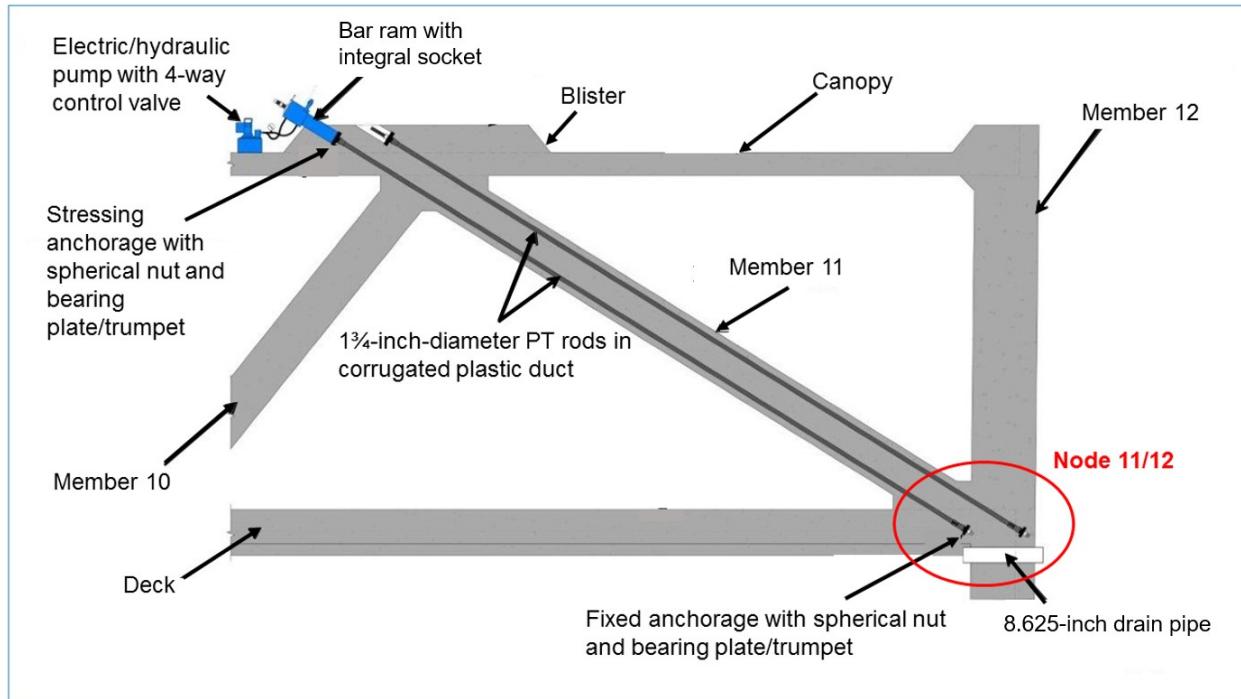
**Figure 19.** Main span, north end, showing post-tensioning specialized equipment in relation to location of PT rods in member 11. (Source: Structural Technologies, annotated by NTSB)

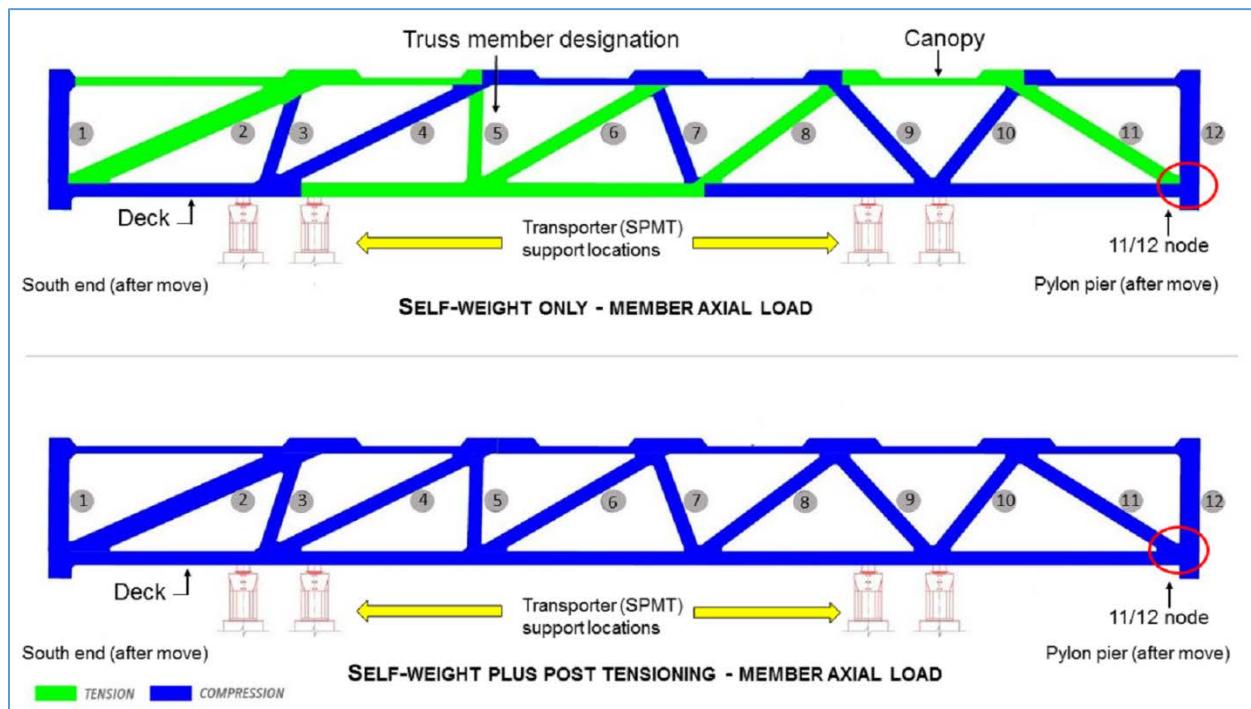
**Figure 20.** Main span tension and compression members for diagonal truss members 2 and 11, which supported each end during SPMT move from casting yard to south and pylon piers. Top illustration is shown without post-tensioning; bottom illustration is shown with actual loads. (Source: FIGG, annotated by NTSB)

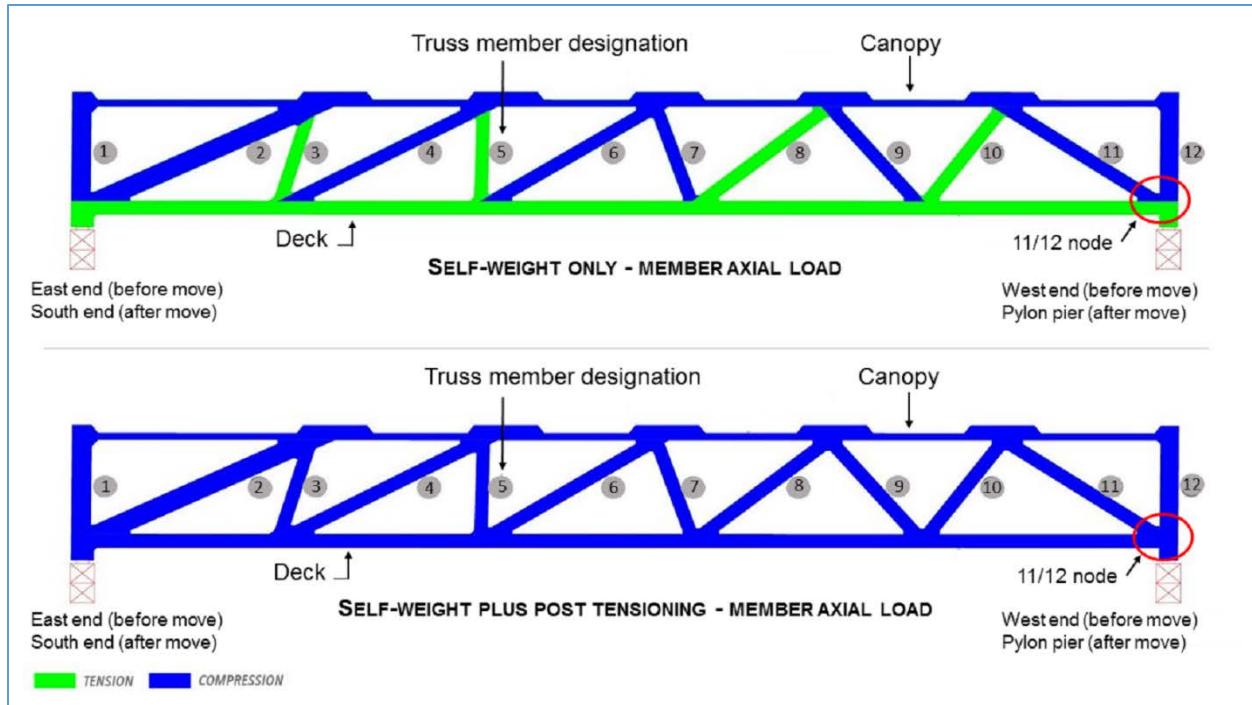
**Figure 21.** Self-weight axial forces only (top) for diagonal truss members 2 and 11, which are combined with post-tensioning forces concurrently acting on main span to produce net axial forces (bottom) at each end before transport and on permanent pier following transport. Top illustration is shown without post-tensioning; bottom illustration is shown with actual loads. (Source: FIGG, annotated by NTSB)

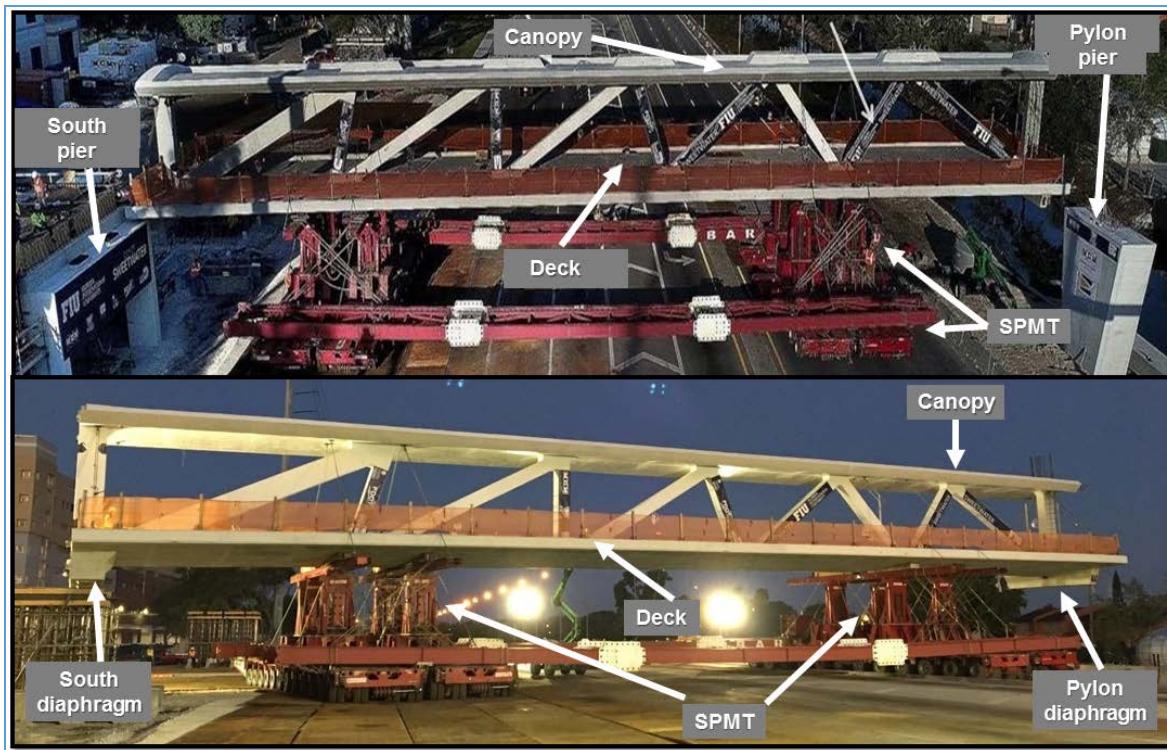
**Figure 22.** SPMT being moved overnight on March 10 (bottom) and main span being placed on south and pylon piers, facing west (top). Transport occurred over 8 hours, starting at 4:30 a.m., with placement of final permanent pier support concluding at 12:30 p.m. (Source: FIGG, annotated by NTSB)

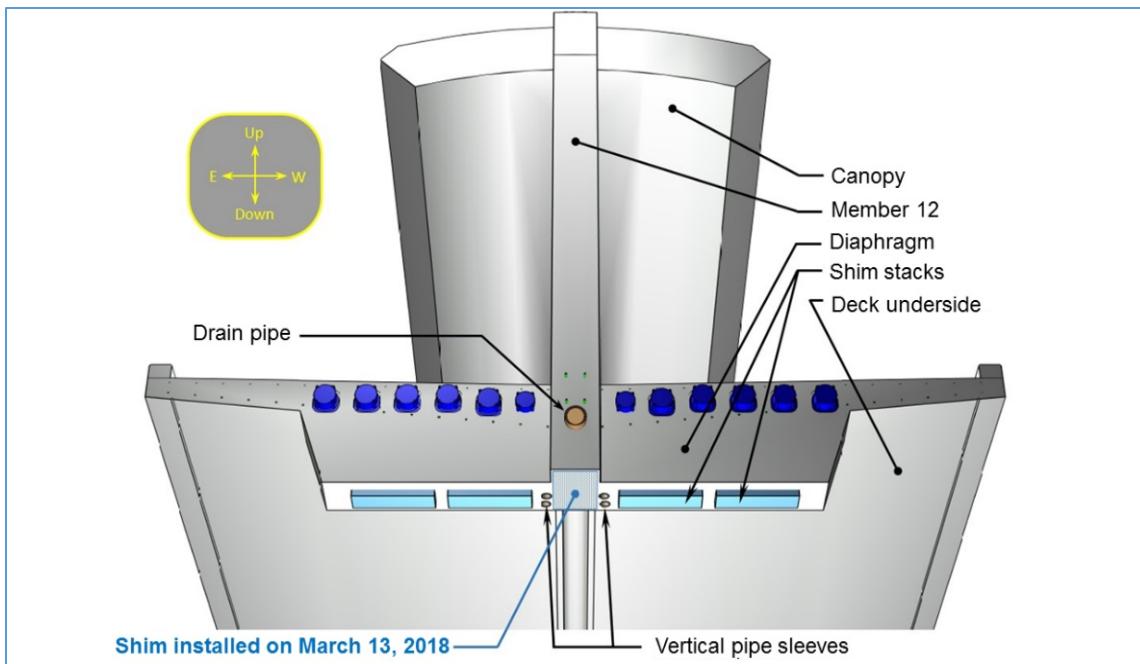
**Figure 23.** View of underside of post-SPMT support location of pylon diaphragm onto pylon pier, showing shim stacks on east and west side of diaphragm centerline. Post-SPMT support location is at underside of pylon pier deck. (Source: FHWA 2019)

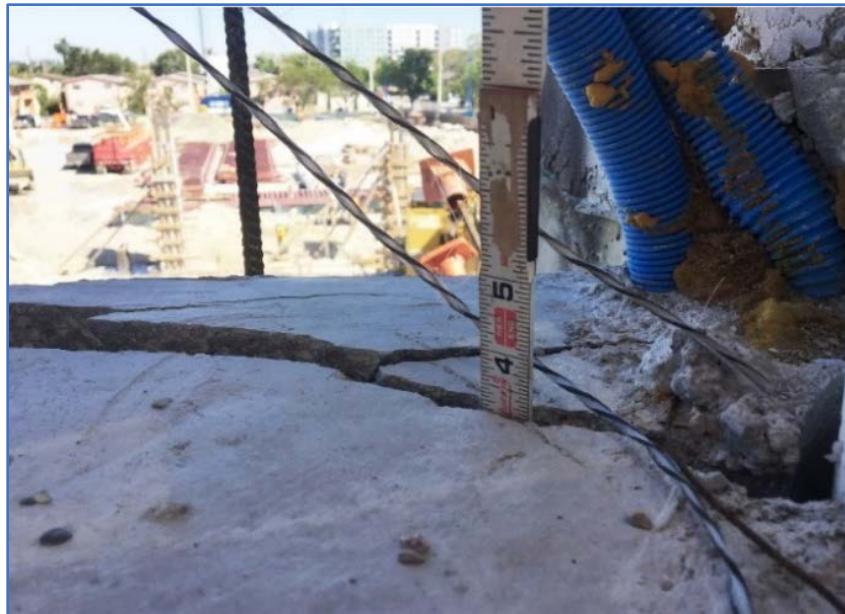
**Figure 24.** Cracks of 3–4 inch depth at northern end of precast main span, along west side of diaphragm 2 (north view), March 13, 11:17 a.m. (Source: MCM)

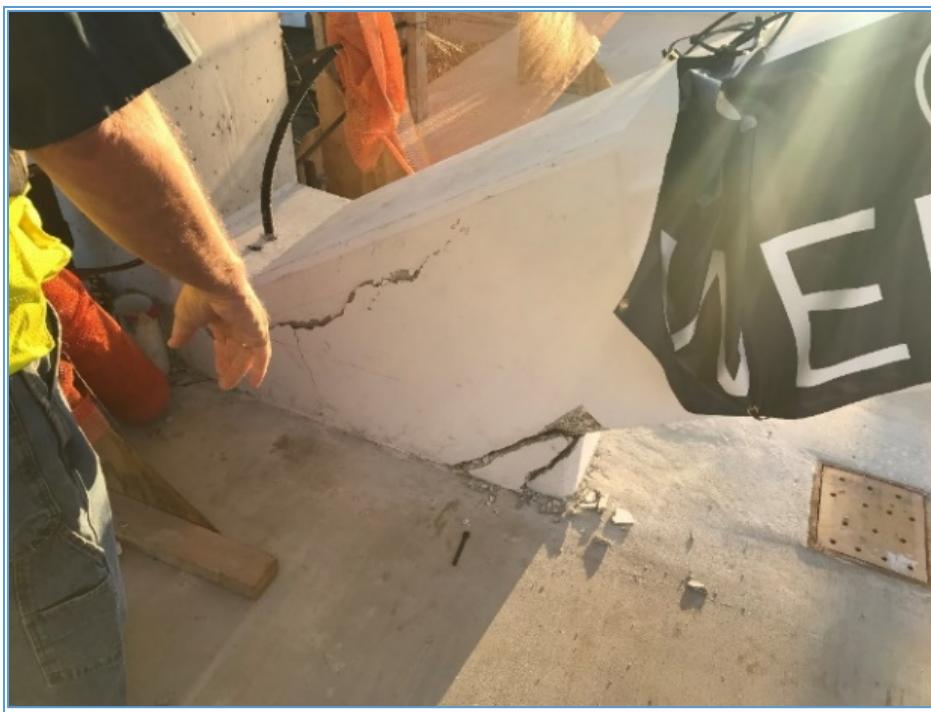
**Figure 25.** Cracks at bottom of diagonal member 11 (west view), March 15. (Source: FIGG)

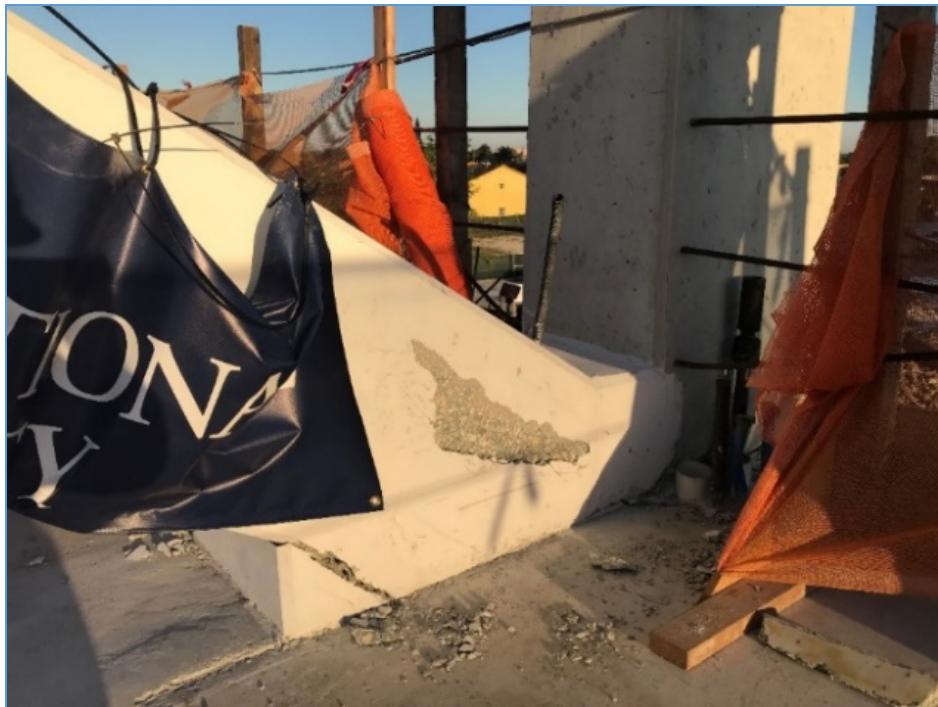
**Figure 26.** Cracks at bottom of diagonal member 11 (east view), March 15. (Source: FIGG)
