# Pedestrian Bridge Collapse Over SW 8th Street Miami, Florida March 15, 2018

## Accident Report

NTSB/HAR-19/02  
PB2019-101363

National  
Transportation  
Safety Board

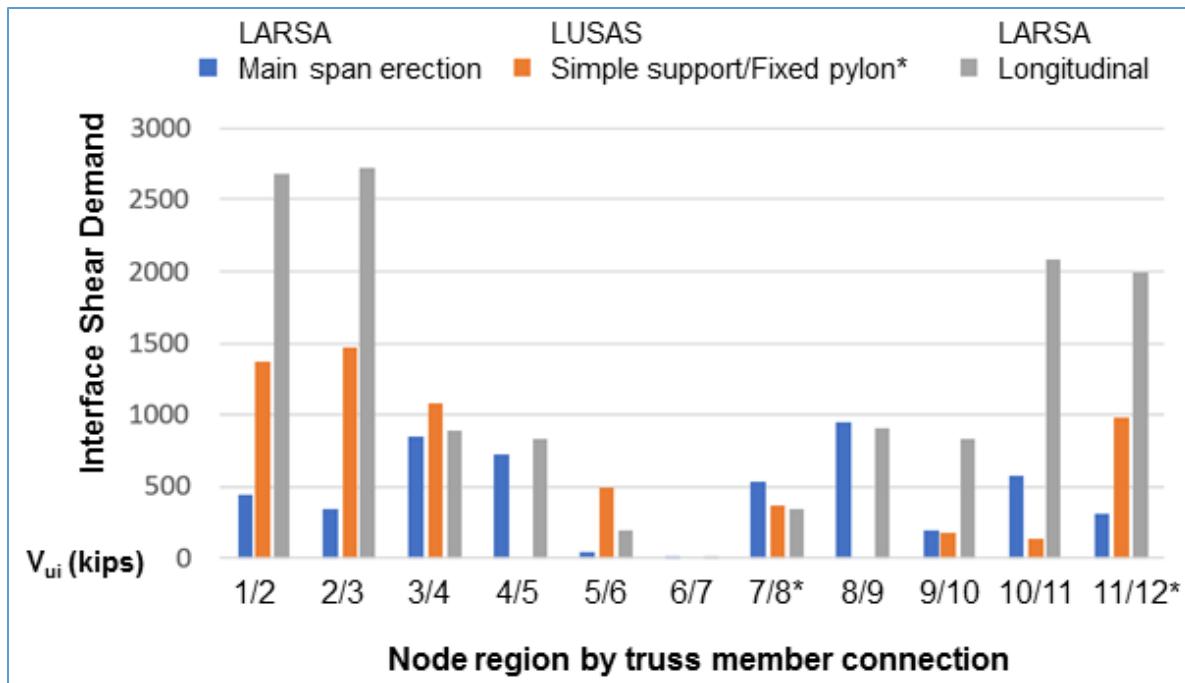
**Figure 27.** Nodal region interface shear demand results generated for FIGG bridge design, with horizontal axis showing two truss member identification numbers that connect into each nodal region. (Source: FHWA 2019)

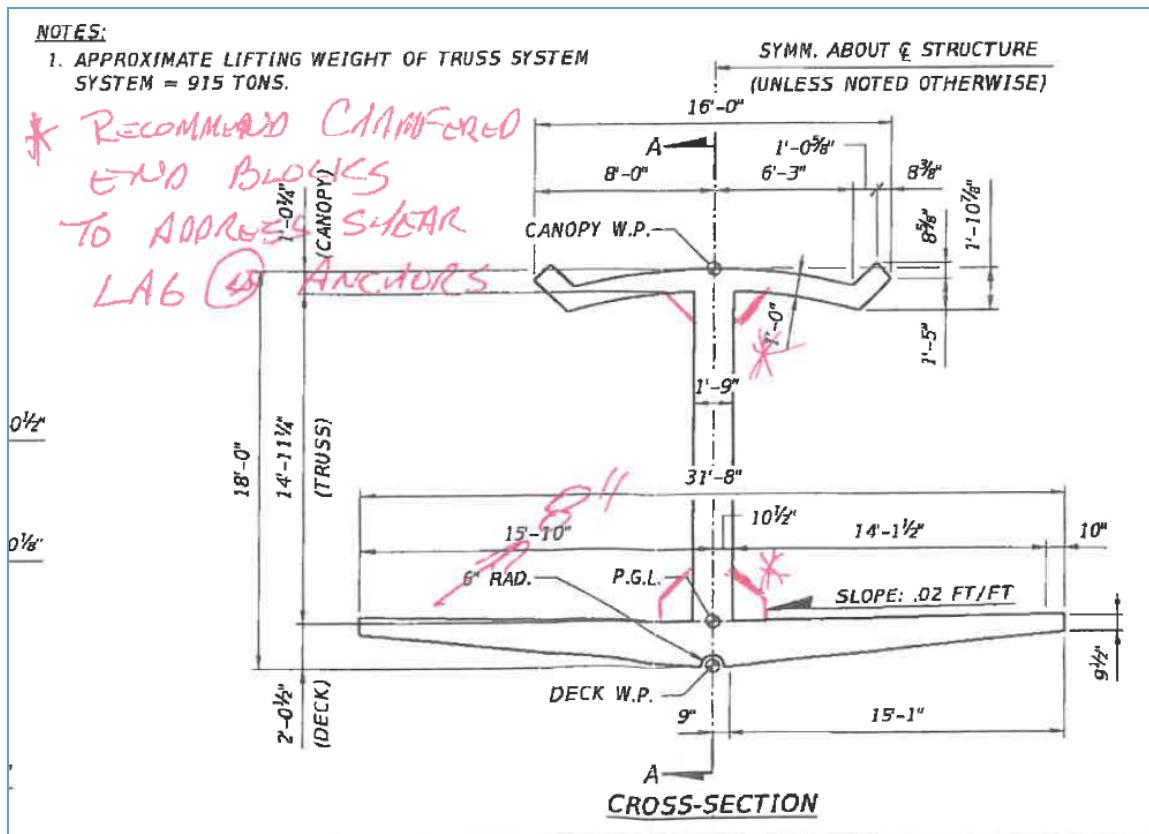
On September 16, 2016, FDOT had specifically commented to FIGG on the *main span truss system* layout (sheet B-36), as shown in figure 28: "Recommend chamfered end blocks to address shear lag at anchors (where the truss members connect to the canopy and bridge deck at the end of the bridge span where the longitudinal PT terminates)."

**Figure 28.** FDOT comments to FIGG on main span truss system layout, recommending chamfered end blocks to address shear lag at anchors. (Source: FDOT)

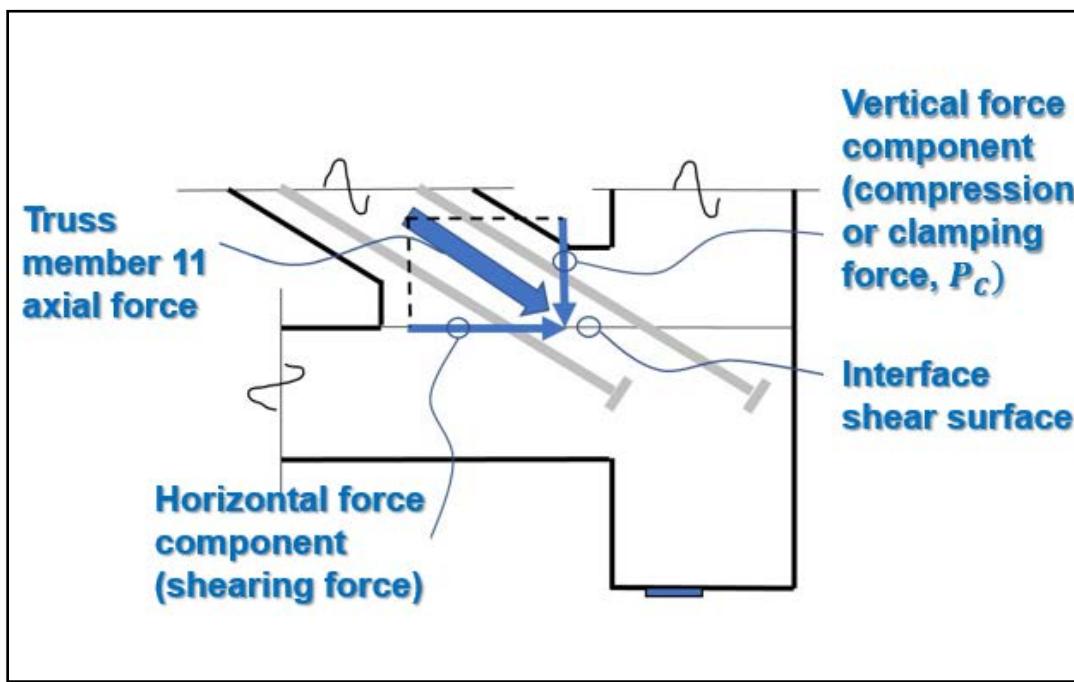
The horizontal force component of member 11 acted as the shearing force on the interface shear surface (deck) and was the interface shear demand. The vertical force component of member 11 acted as the compressive, or clamping, force that contributed to interface shear resistance (resisting member 11 from shearing or sliding horizontally off the deck). (See figure 29.) When FIGG made the error of using the incorrect  $P_c$  factor in its calculation, this artificially increased the perceived clamping forces available. The artificial increase of weight that resulted from FIGG's incorrect use of a 1.25 load factor (upper bound) led to a determination that there was more clamping force available for resistance to interface shear than actually was available, which resulted in overestimation of interface shear resistance. This means that the actual interface shear resistance was considerably less than FIGG calculated, and the interface shear resistance of member 11 was therefore unable to resist the shear forces, leading to failure at this critical location, causing the bridge collapse.

**Figure 29.** Depiction of axial force from truss member 11 on nodal region interface shear surface. (Source: FHWA 2019)

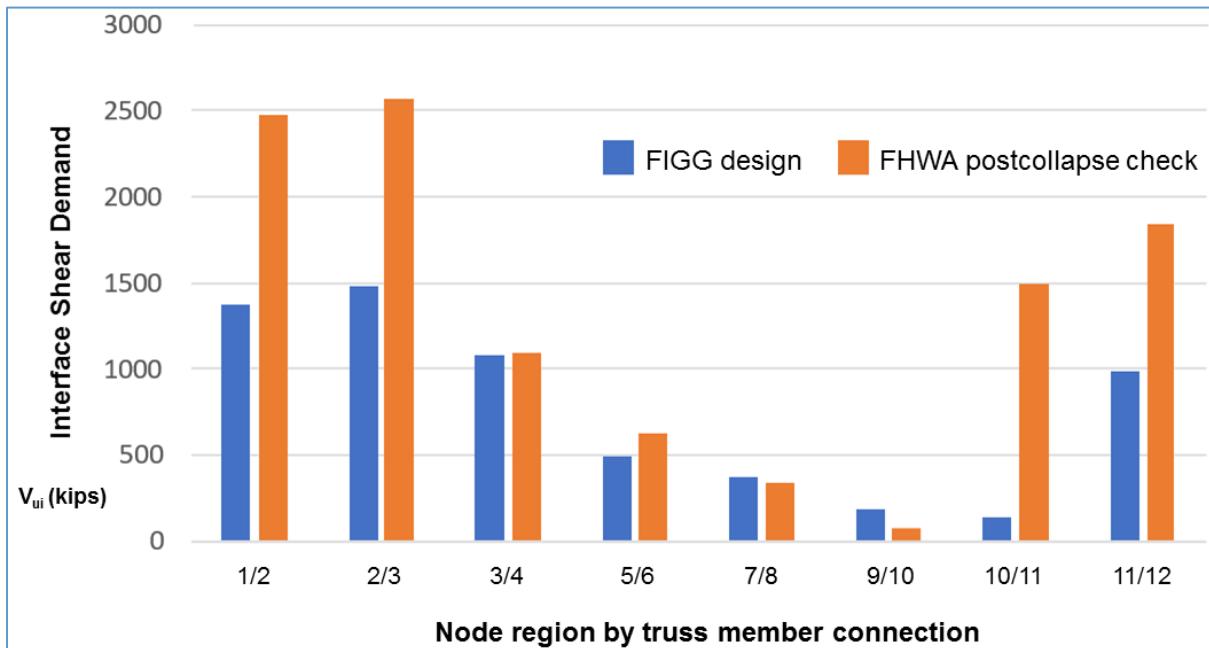
**Figure 30.** Comparison of nodal region horizontal shear modeling results from FIGG design and FHWA analysis. (Source: FHWA 2019)

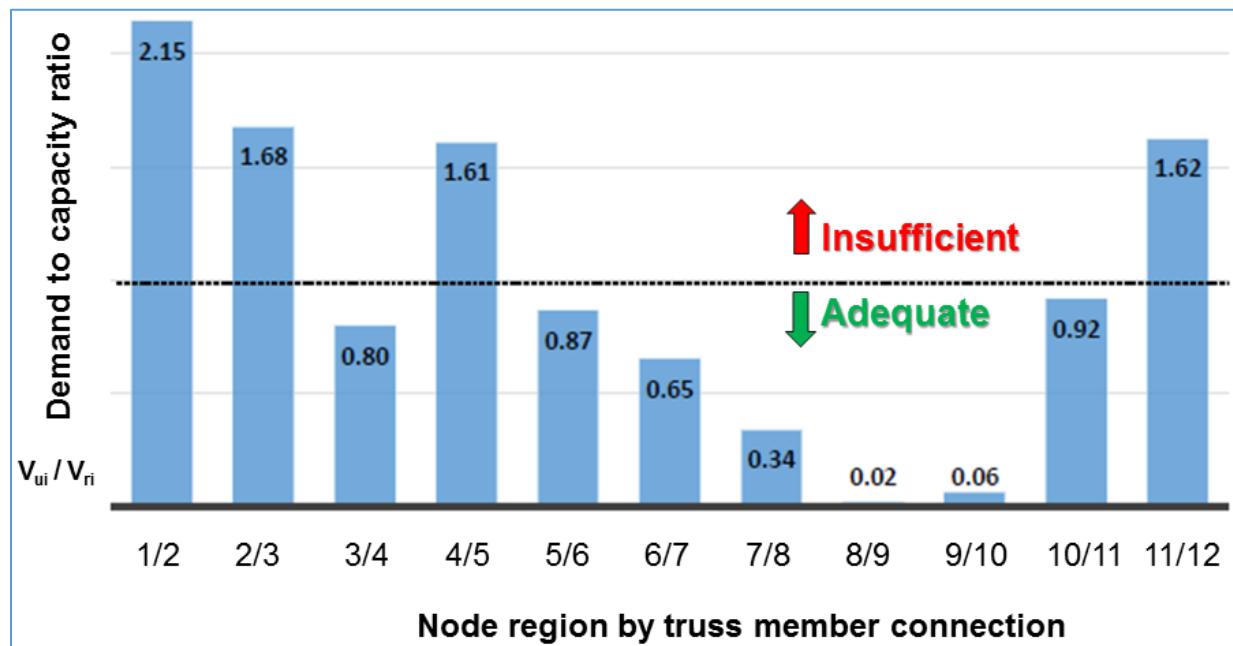
**Figure 31.** D/C ratios for main span nodal regions. (Source: FHWA 2019)

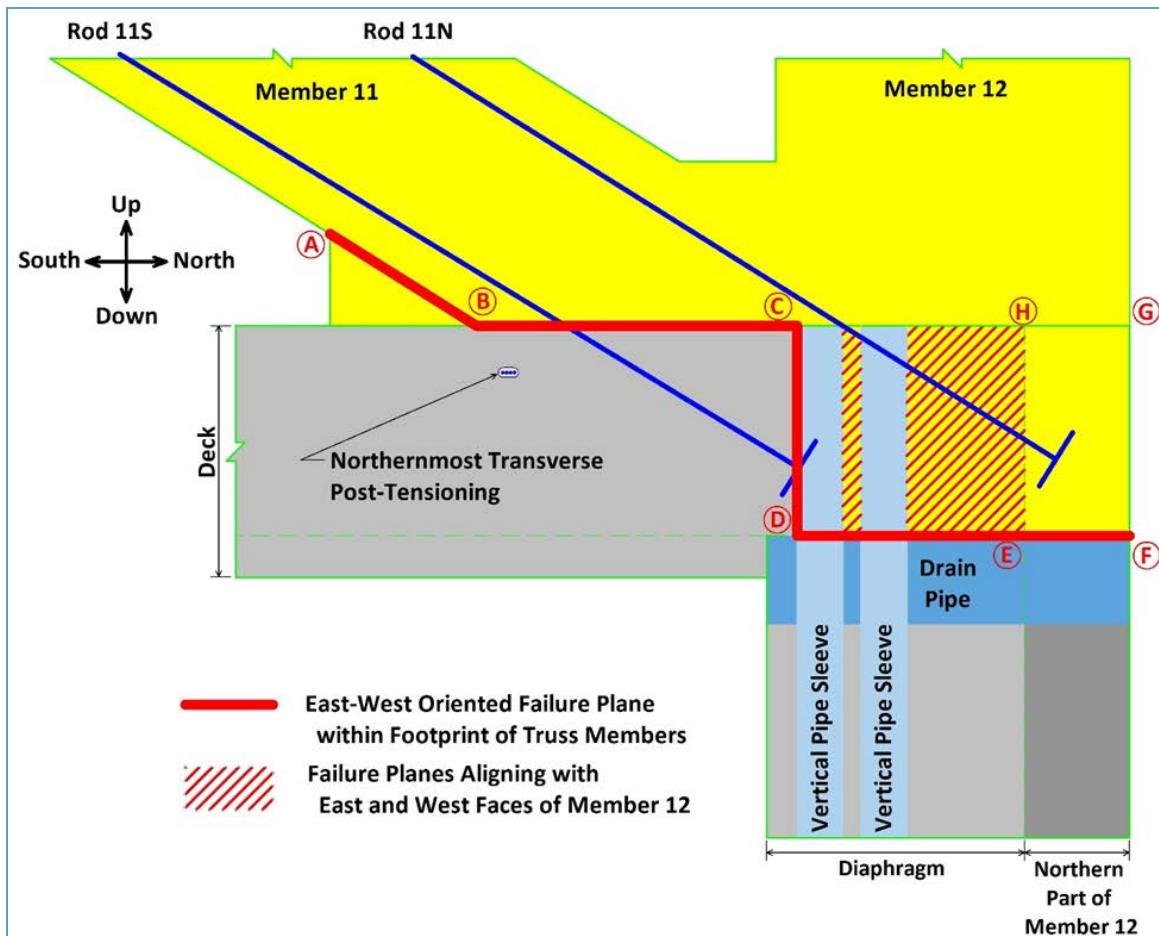
**Figure 32.** Midline cross section of member 11/12 nodal region, with annotations indicating resistance mechanisms and distress. (Source: FHWA 2019)

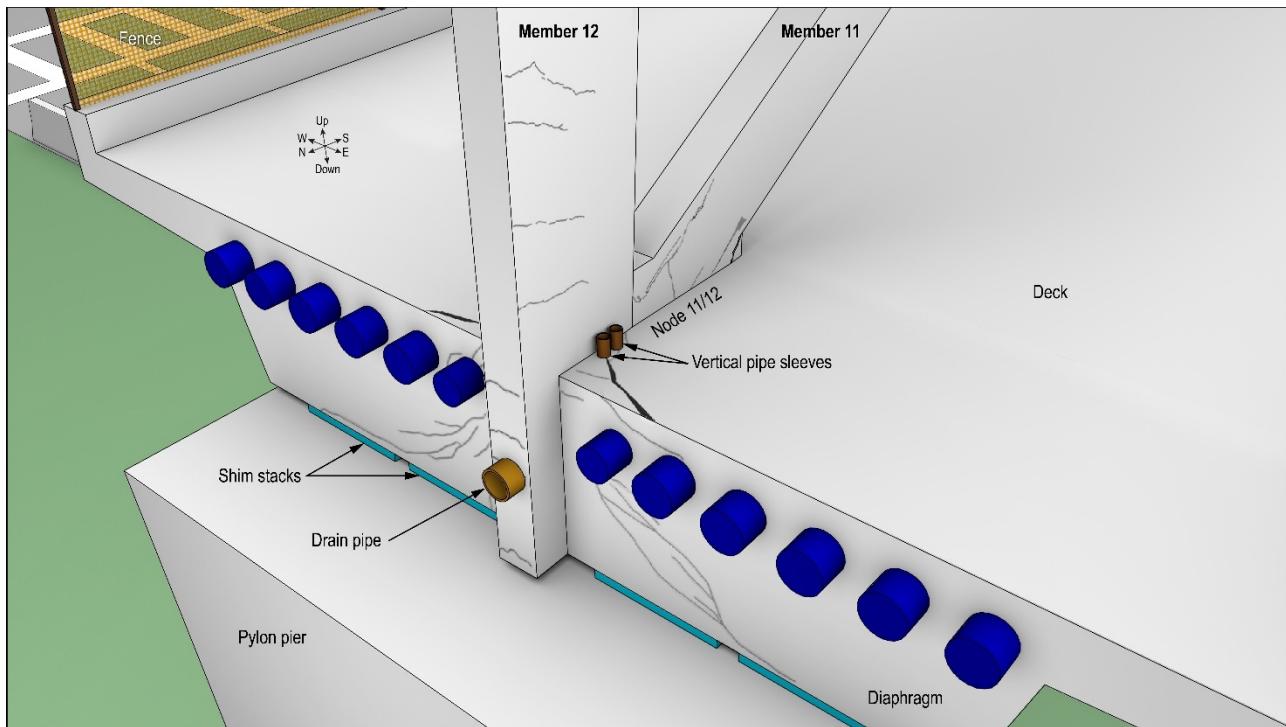
**Figure 33.** South and west view of extent of cracking at member 11/12 nodal region, deck, and diaphragm, indicating structural distress.

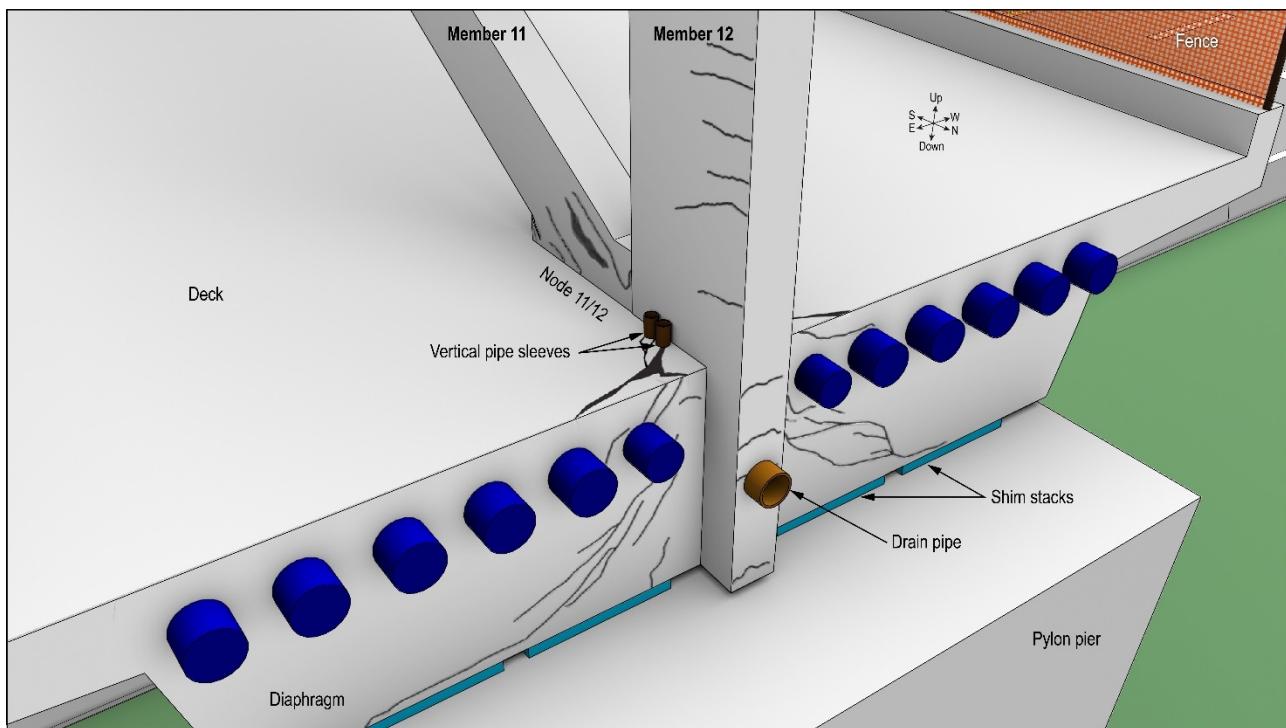
**Figure 34.** South and east view of extent of cracking at member 11/12 nodal region, deck, and diaphragm, indicating structural distress.
