28 December 2021

Project 147041.10 – 301 Mission Street
Perimeter Pile Upgrade
Projection of Building Settlement Through Construction Completion

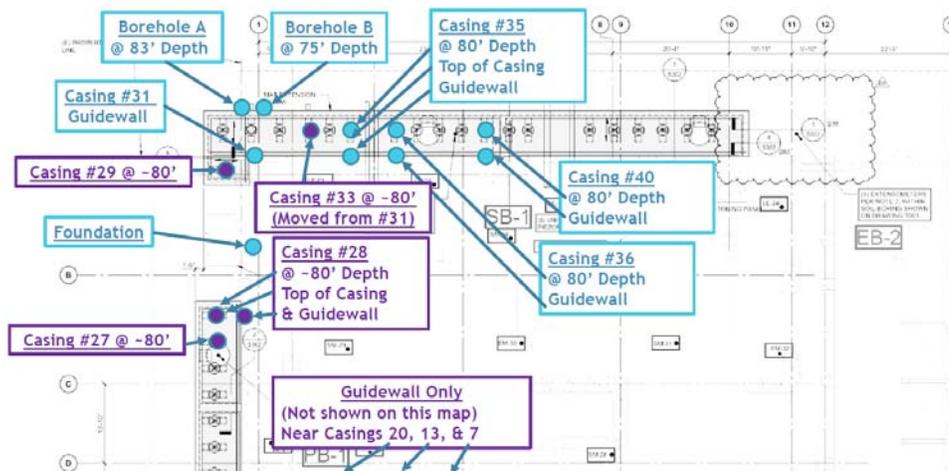
Figure 5 - Locations of Vibration Sensors

Figure 5 shows the locations of vibration sensors during the pilot installations of 36 in. casings, at locations 32, 33 and 34, and also during the installation of 24 in. pilot piles at locations 30 and 31. Figure 6 shows the mean and maximum root mean square velocities recorded within the Colma formation during the installation of the 36 in. casing at location 33. The maximum vibration amplitudes recorded at depth were on the order of 600 micro-m/s and occurred during excavation of soil from within the casing using the auger bucket, as the casing tip was extended from the 70 ft to 90 ft depth, that is within the lower Colma formation.
